(Draft) EMS's views against JAPC's claim concerning the fault evaluations of Tsuruga PS site, EMS on shatter zones in the site of Tsuruga Power Station		JAPC's opinion	Reference No.
Main texts	Issues		
<p><EMS's views on the claim 2> The evaluation report states that the K fault is 'the structure which continues to the D-1 shatter zone'. The reasons are as follows;</p> <p>(1) As stated in the 'Claim 1', the specialist of geology pointed out as follows, concerning the thin section observations implemented for the G fault and the D-1 shatter zone; - (Skipped) In this way, EMS considers that <u>the evaluation of displacements are not reliable and provides insufficient evidence for the claim that there is no connection between the K fault and the D-1 shatter zone.</u></p>	Same as the Claim 1.	Same as our view on the Claim 1 in the EMS.	—
<p>(2) Especially, the point where the strike of the K fault is bent to the NNW – SSE direction* was <u>recognized mainly in the deposits above the bedrock</u>. In general, the strikes and dips of the faults found in deposits are not constant and they could vary from place to place. Therefore, <u>it is not possible to conclude that the K fault does not

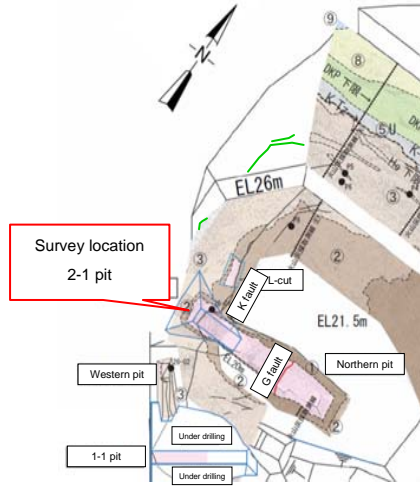
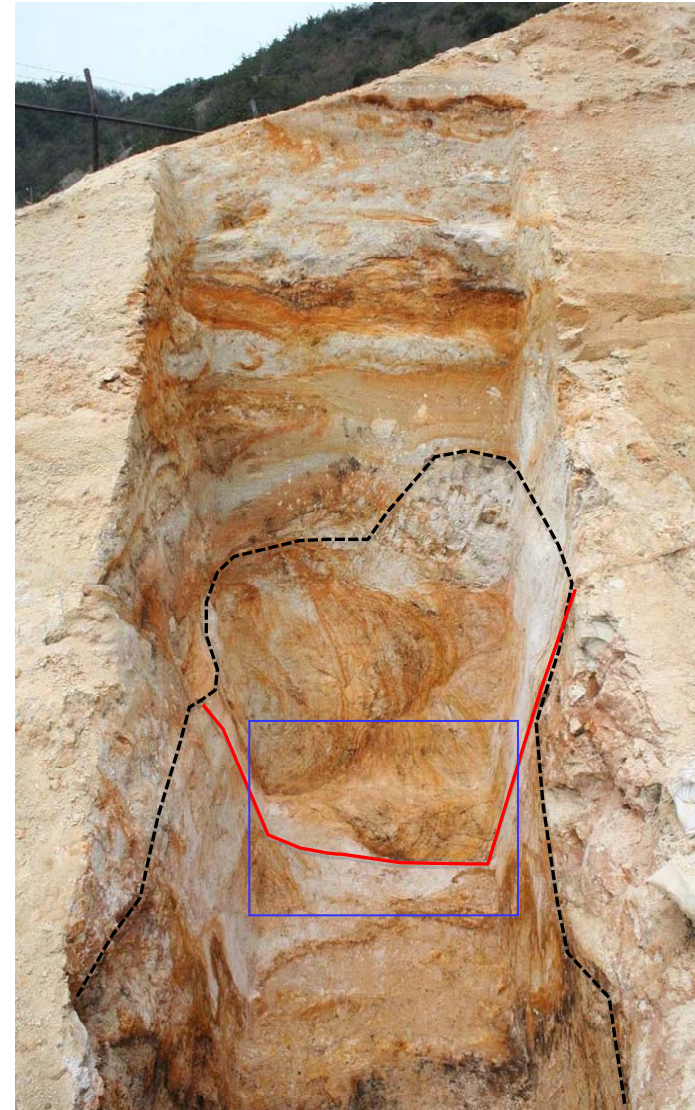
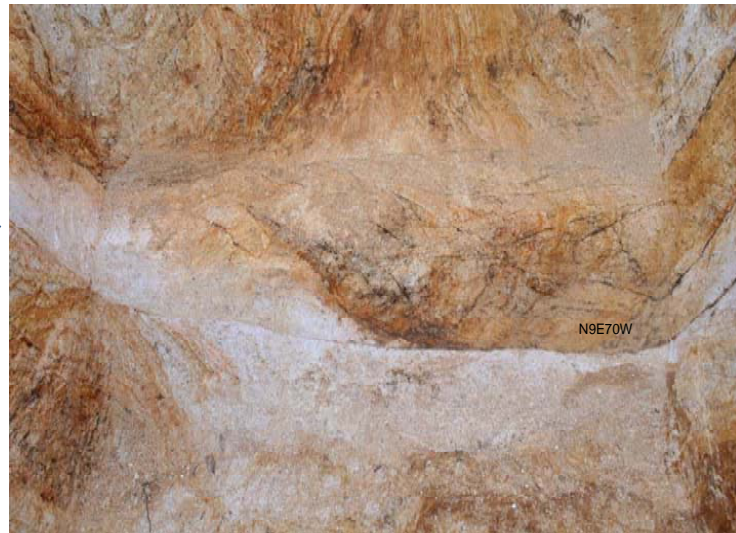
• At D-1 trench, 2-1 and 1-1 pit surveys have been carried out in order to clarify the characteristics, strike, and dip within the basement of the K fault.

- It is confirmed that the K fault strike is a direction of N-S within the basement based on the result of 2-1pit boring in the side of L-cut pit of D-1 trench.

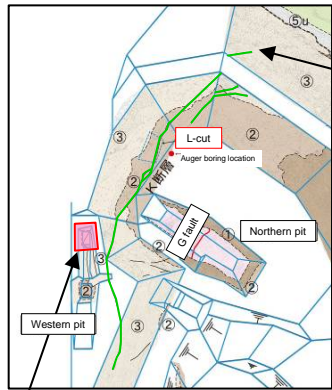
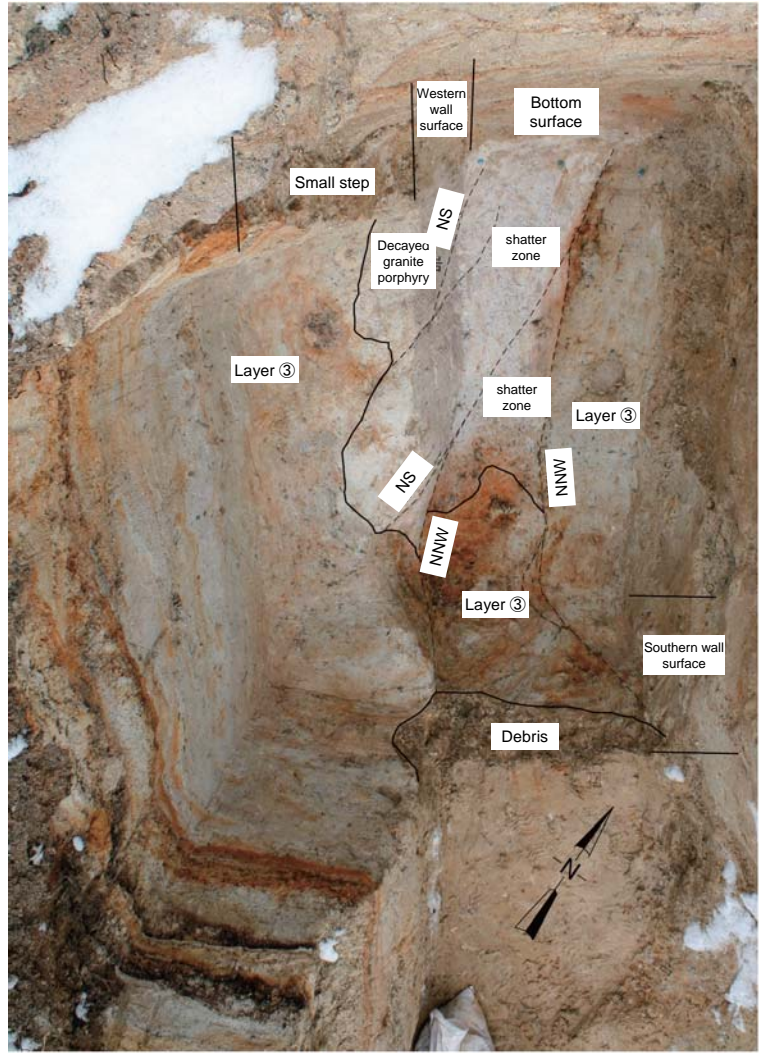
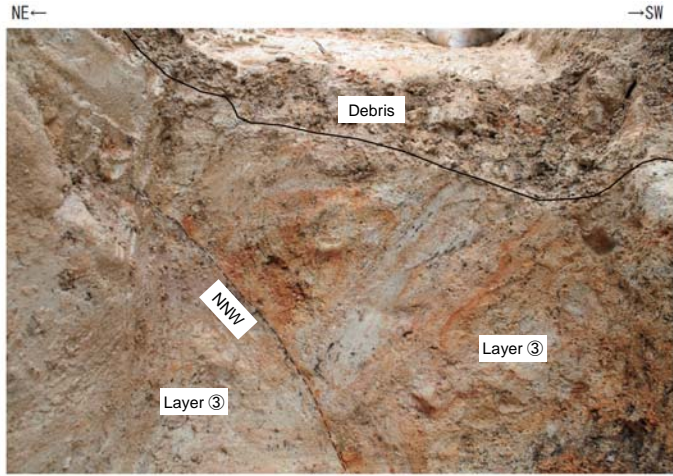
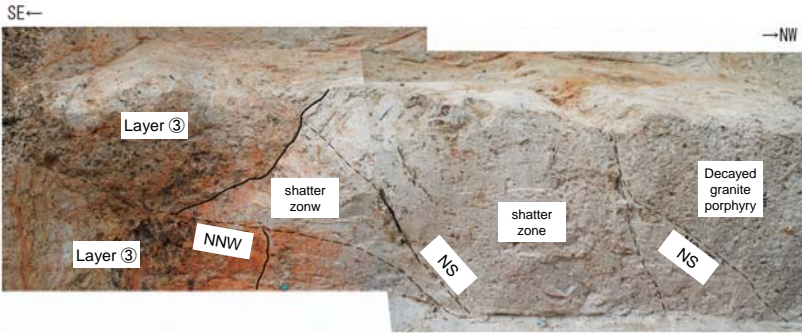
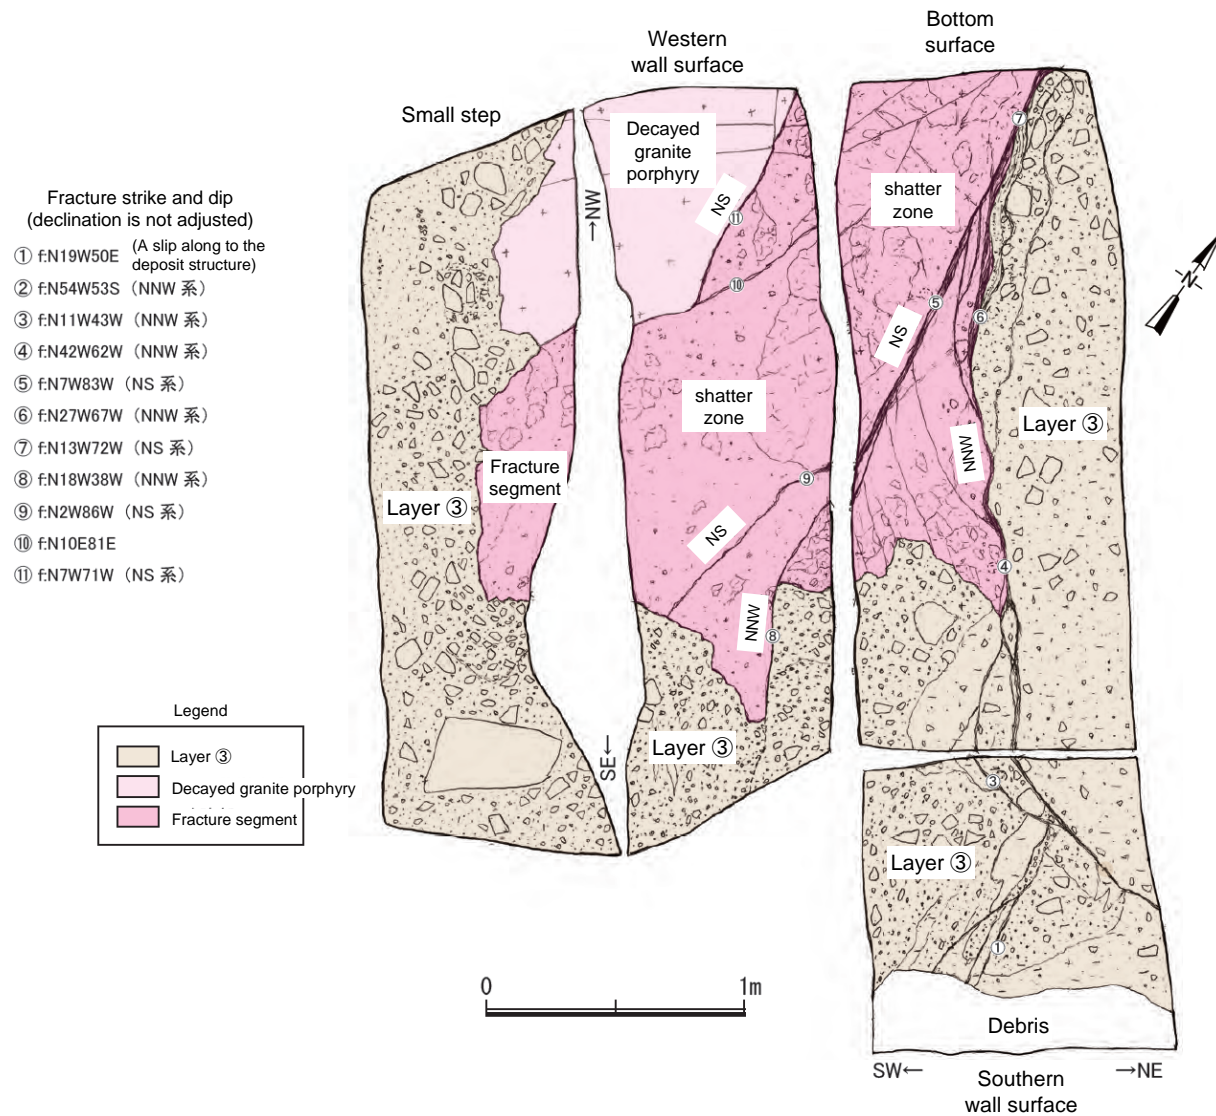
Survey on continuity of the K fault Northern widening of western pit

- The shatter zones running to the directions of N-S and NNW-SSW are recognized in the basement rock at the northern widening of western pit.
- The K fault, which displaces and deforms layer ③, has changed its strike directions from N-S to NNW-SSW in the western pit.
- The fracture segment with N-S direction strike does not displace and deform layer ③ in the south part from the bend.

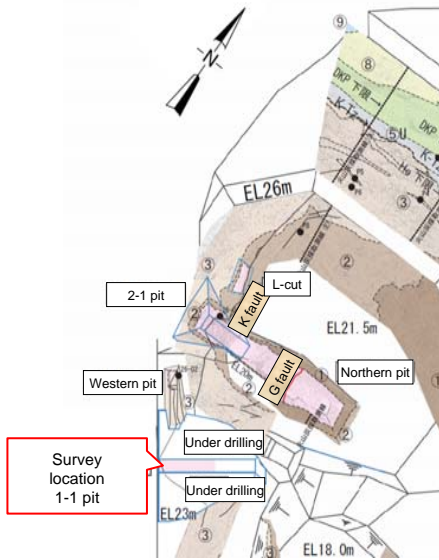
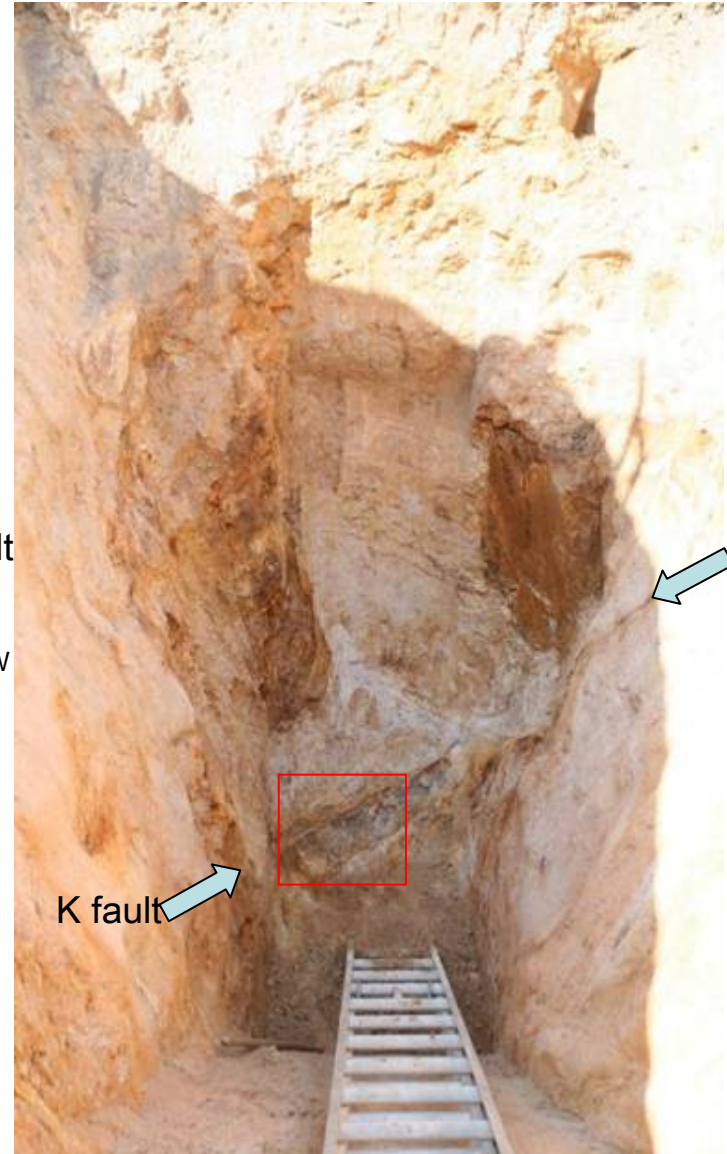
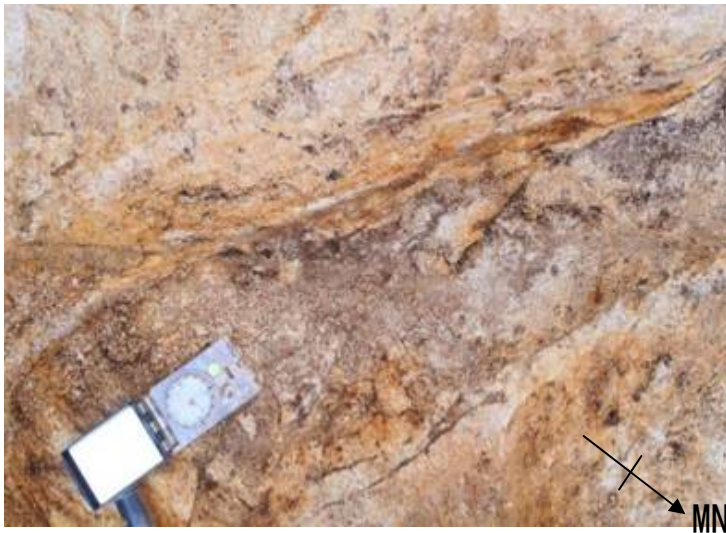
Survey on continuity of the K fault 1-1pit (advance report)

K fault
N56W53SW

- In the result of 1-1pit boring in the south of western pit of D-1 trench, K fault indicate NW-SE strike in the basement. It is confirmed that the K fault does not extend to the direction of Unit 2 reactor building.

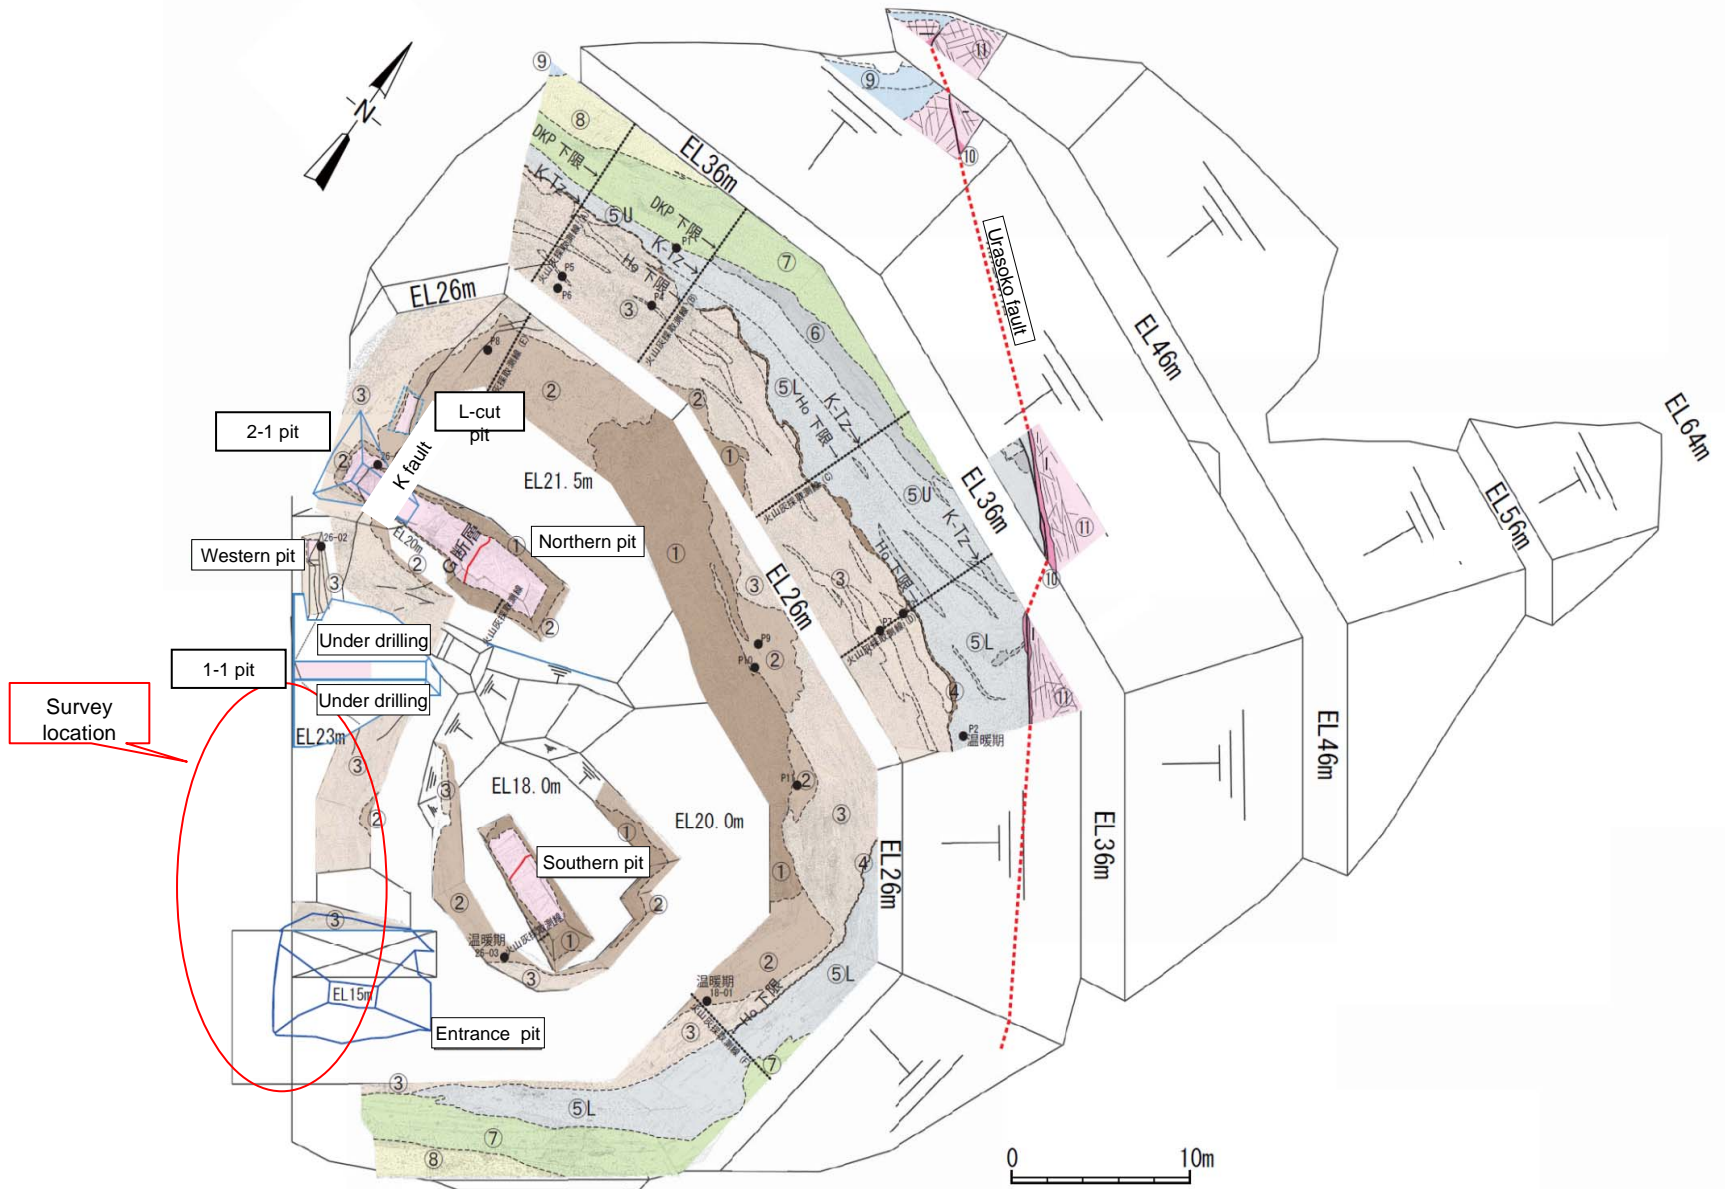
Pit survey plan regarding continuity of the K fault and activity of the G fault

For further clarification of continuity of the K fault, activity of the G fault and so on, additional pit surveys are undergoing now.

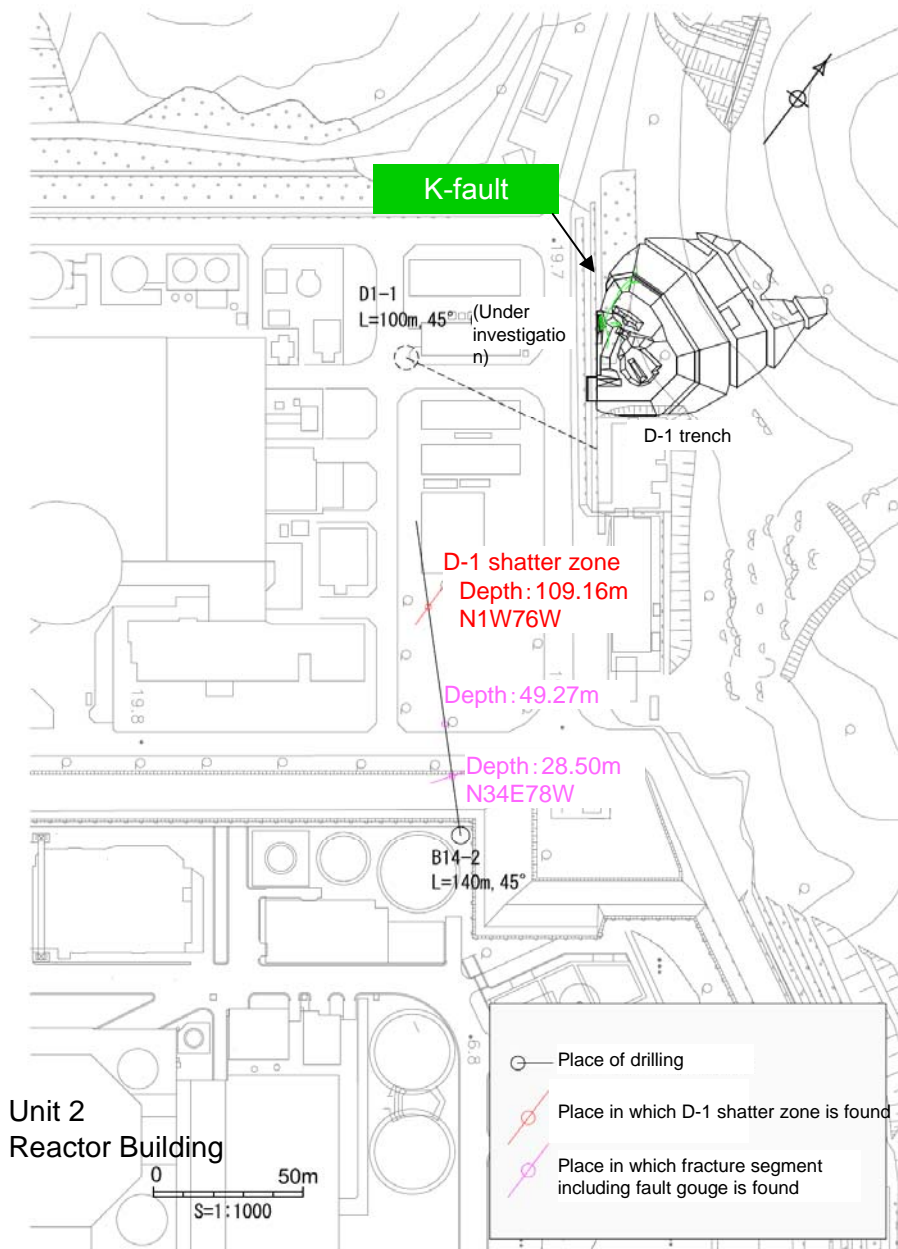
- Three fracture segments with fault gouge have been found at B14-2 drilling, that cross the line between Unit 2 reactor building and K-fault.
- Displacement sense of the last slip has normal fault sense at each fracture segments.

- K-fault, that has reverse fault sense, does not extend to the southward from at least B14-2 drilling place.
- ※To obtain the additional data, drilling at D1-1 is undergoing.

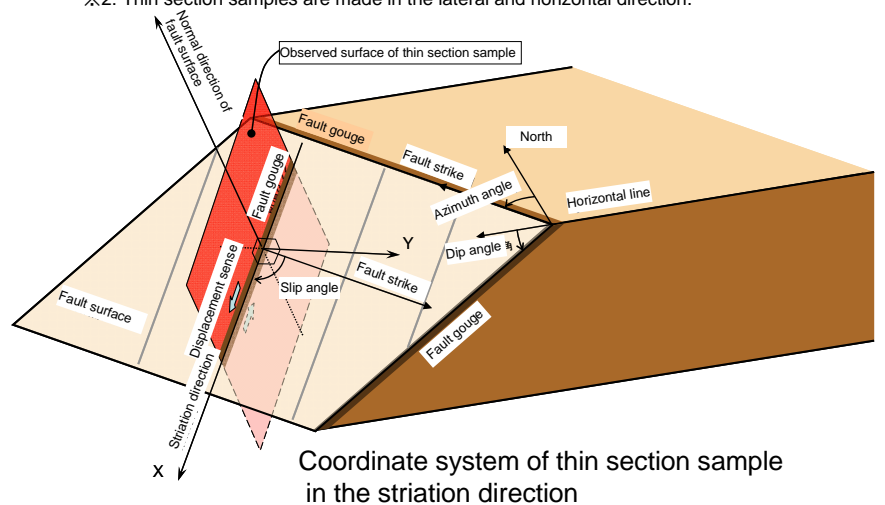
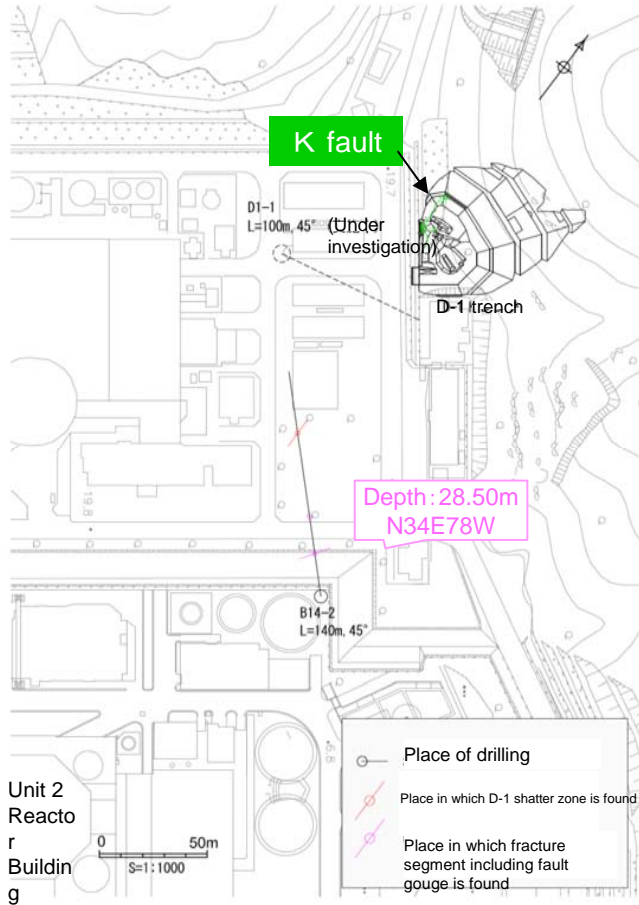
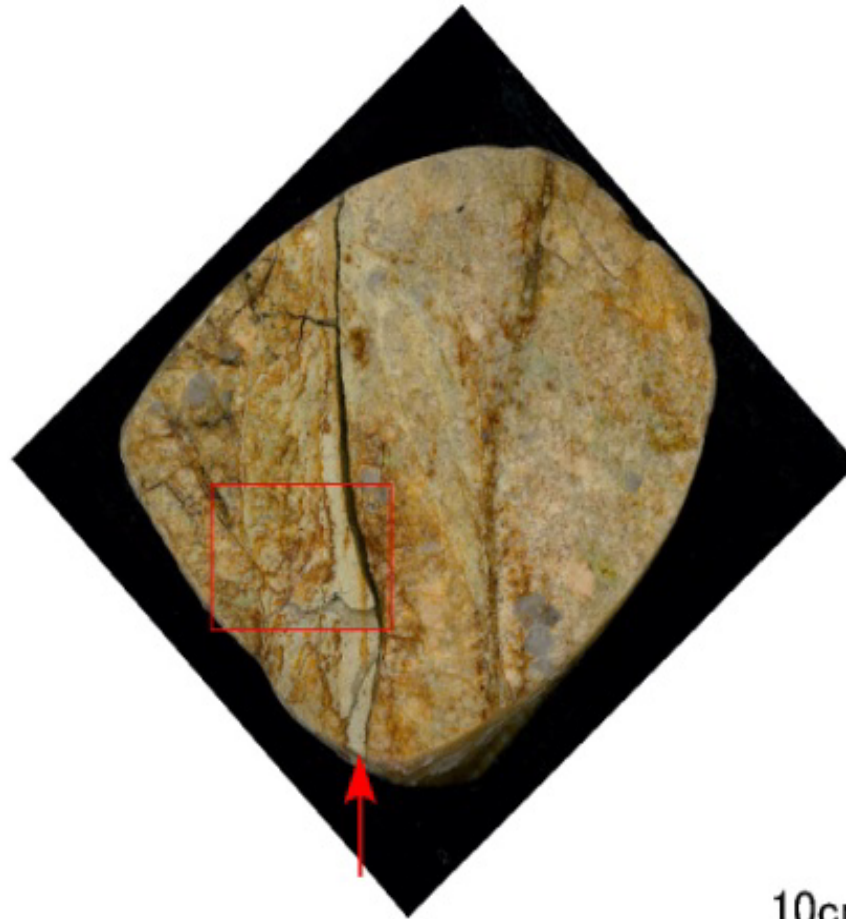
[Displacement sense of shatter zone] Observation of polished section of B14-2 depth 28.50m (middle-angle southerly dips components)

Narrow rectilinear fault gouge has been found in the granite porphyry.

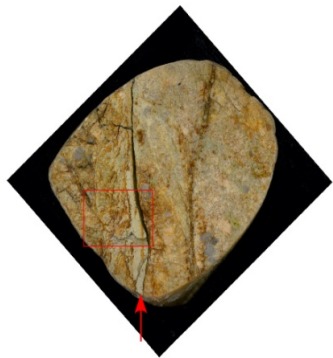
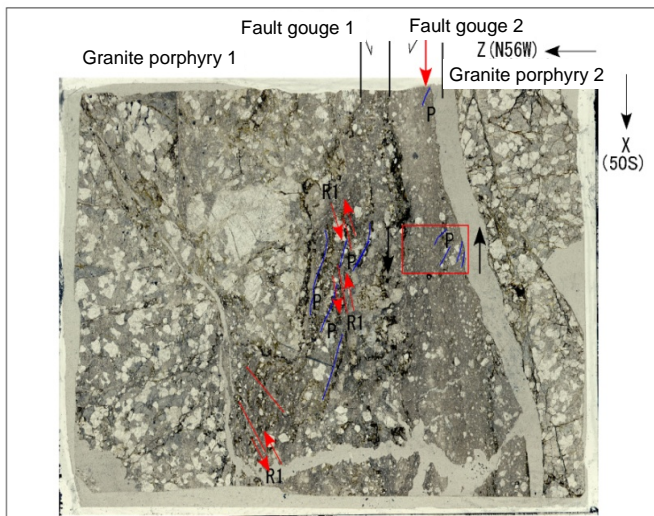
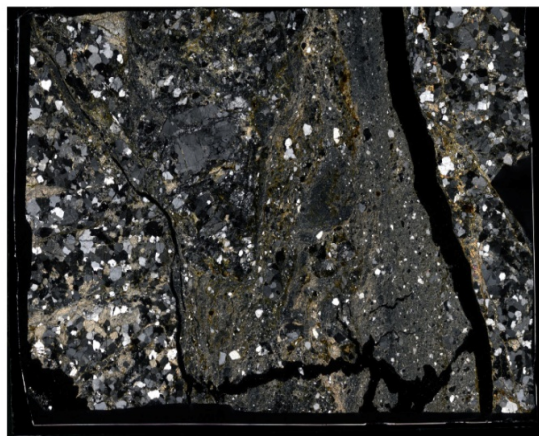
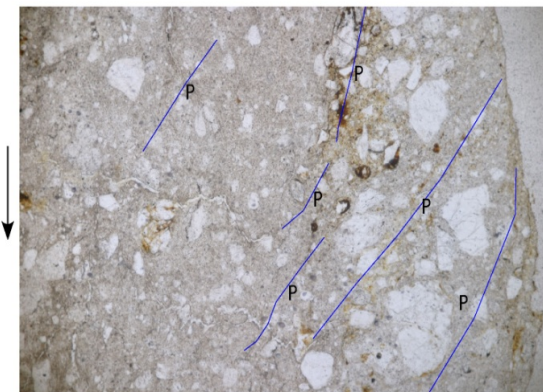
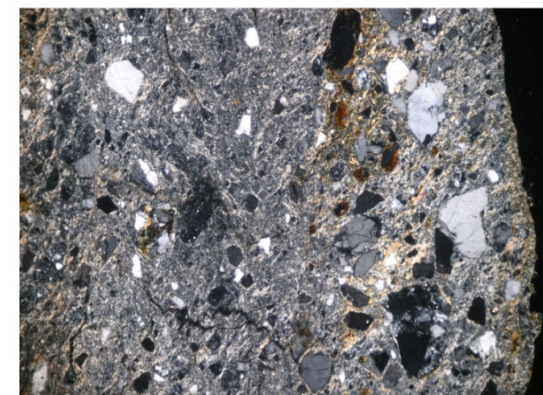
Observation of thin section of B14-2 depth 28.50m (middle-angle southerly dips components)

Consists of the brown-gray matrix of fine grain, as well as quartz, feldspar and cataclastic fragments and that are semi-circular or sub-angular gravels with diameters of 0.02 to 3 mm. The matrix contains lots of clay minerals. The displacement sense of westerly dip (normal fault) and left-lateral slip can be recognized from R1 and P.

Consists of the brown-gray matrix of fine grain, as well as quartz, feldspar, granite porphyry and cataclastic fragments and that are semi-circular or sub-angular gravels with diameters of 0.01 to 1 mm. The matrix contains lots of clay minerals. The displacement sense of westerly dip (normal fault) and left-lateral slip can be recognized from P.

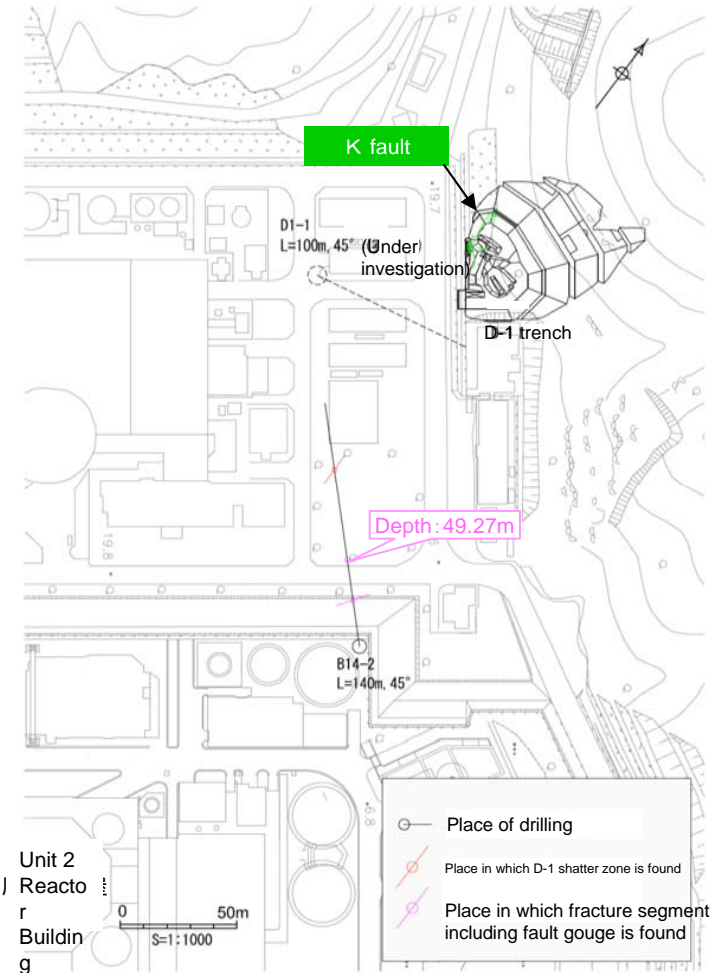
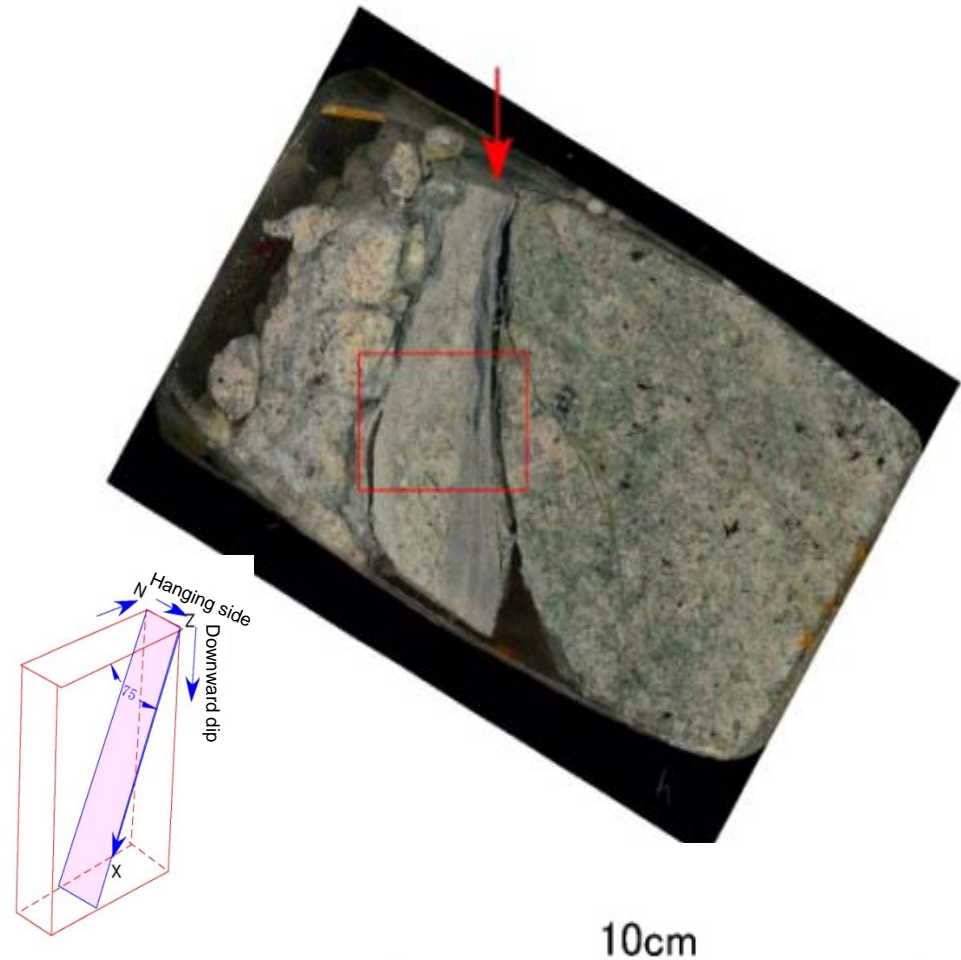
[Displacement sense of shatter zone] Observation of polished section of B14-2 depth 49.27m (high-angle southerly dips components)

※) Fault surface is assumed to be high-angle dip like K-fault, because it was impossible to measure strike and dip by bore-hole TV

- A few millimeter-breadth of fault gouge has been found in the granite porphyry.
- The fault gouges are segmentalized into two. Foliation is developed in the vicinity of last slip surface.

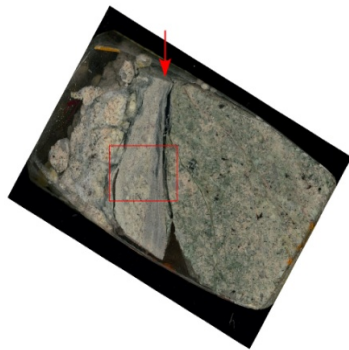
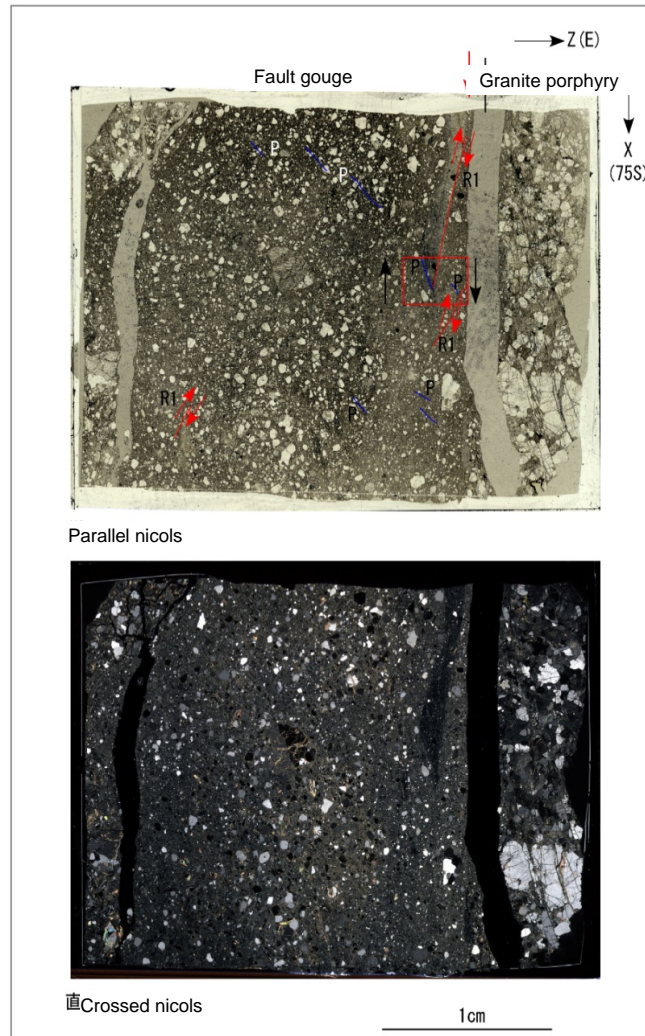
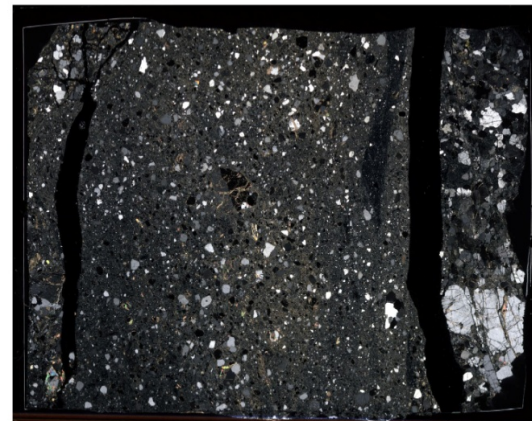
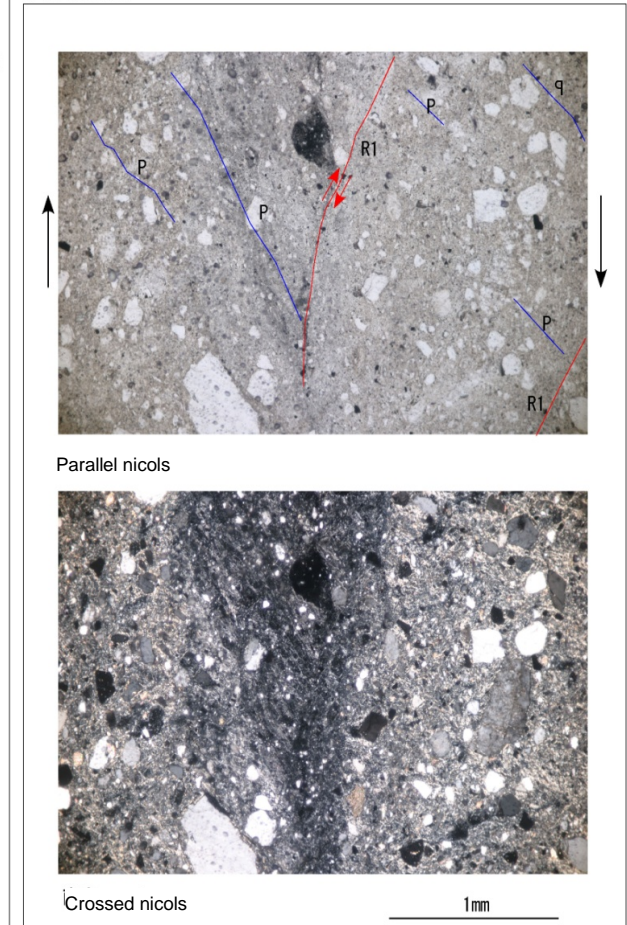
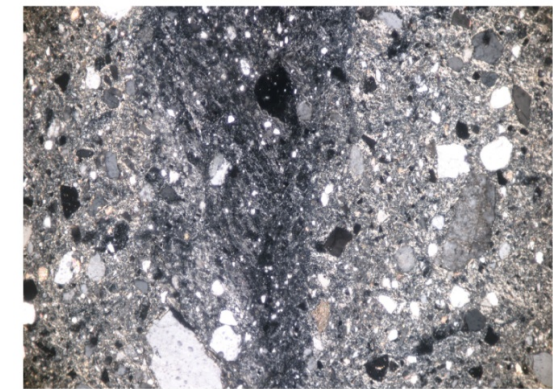
[Displacement sense of shatter zone] Observation of thin section of B14-2 depth 49.27m
(high-angle southerly dips components)

Consists of the brown matrix of fine grain, as well as quartz, feldspar, cataclasite and granite porphyry fragments and that are semi-circular or sub-angular gravels with diameters of 0.02 mm to 5mm. The matrix contains lots of clay minerals and calcite. ~~The displacement sense of easterly dip (normal fault) and right-lateral~~

slip can be recognized from R1 and P.

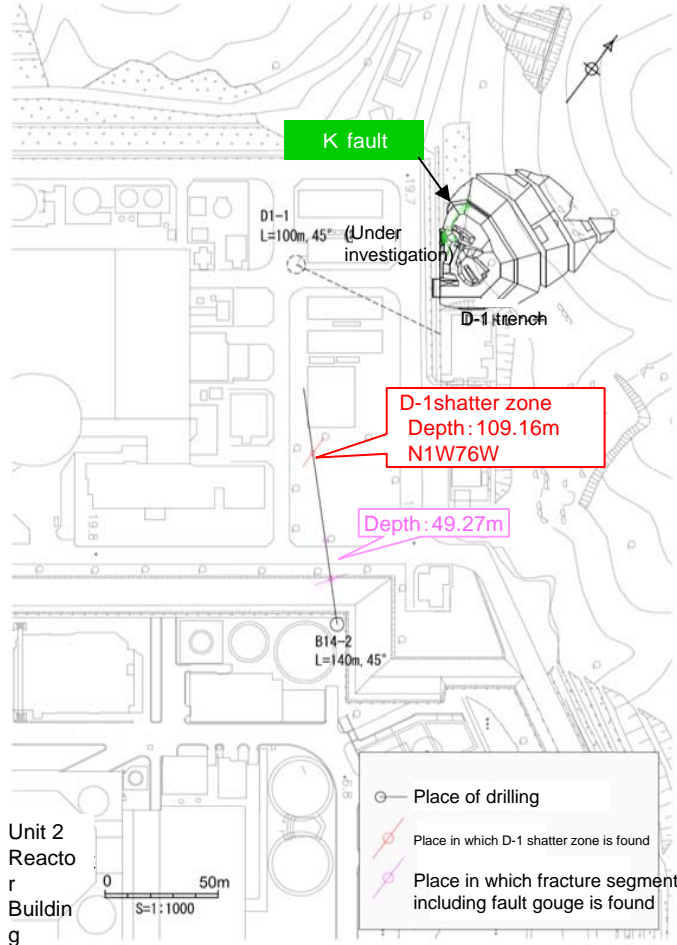
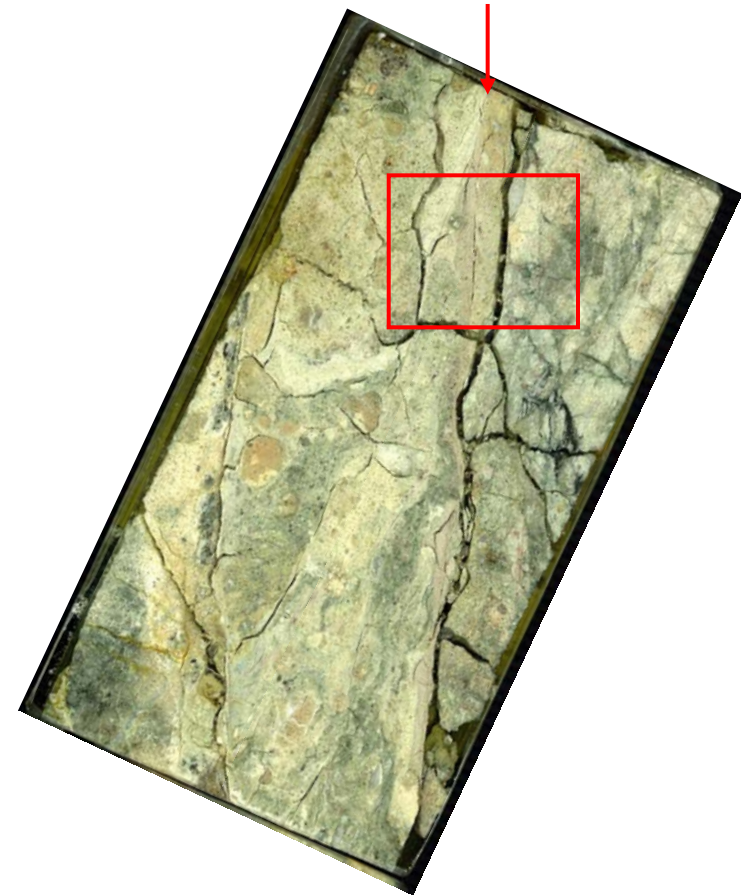
[Displacement sense of shatter zone]
Observation of polished section of B14-2 depth 109.16m (vertical components)

A few millimeter-breadth of fault gouge has been found in the Cataclasite.

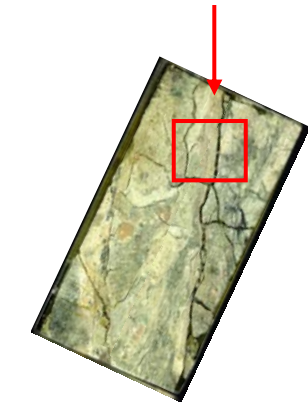
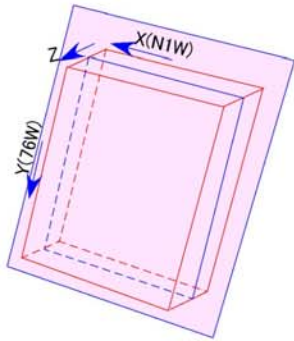
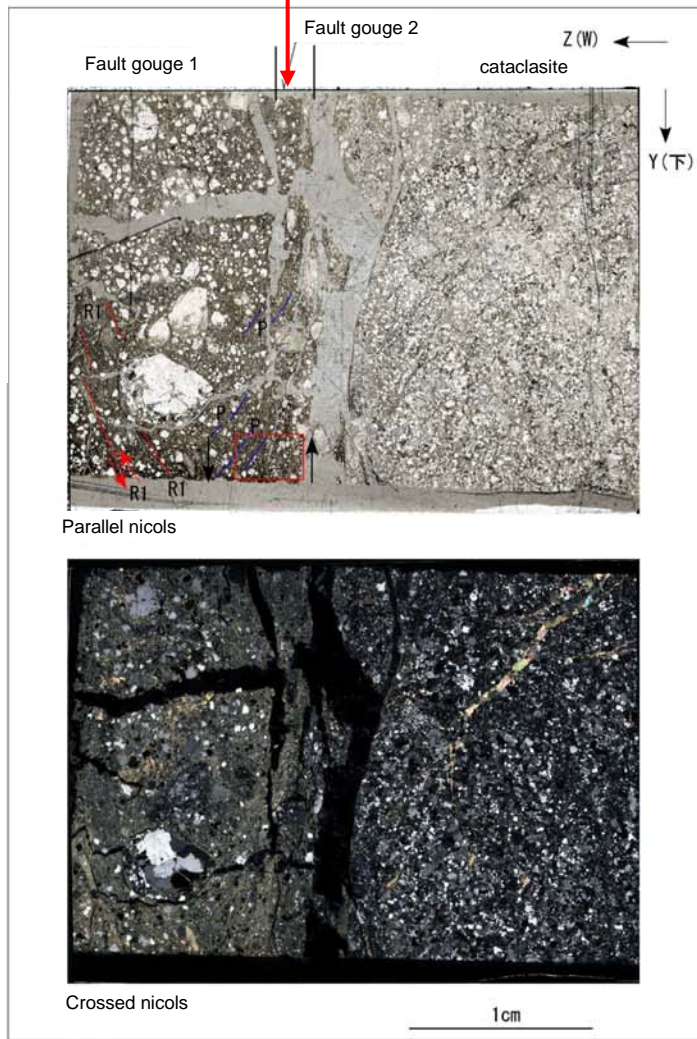
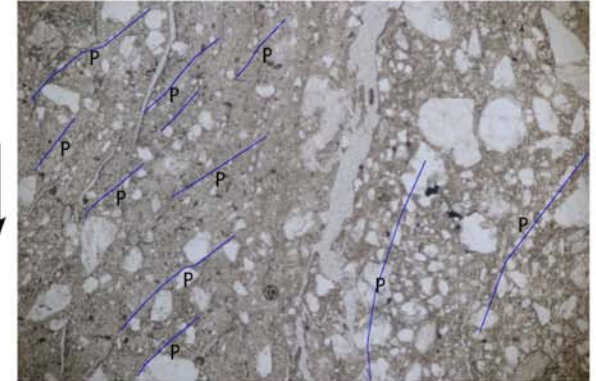
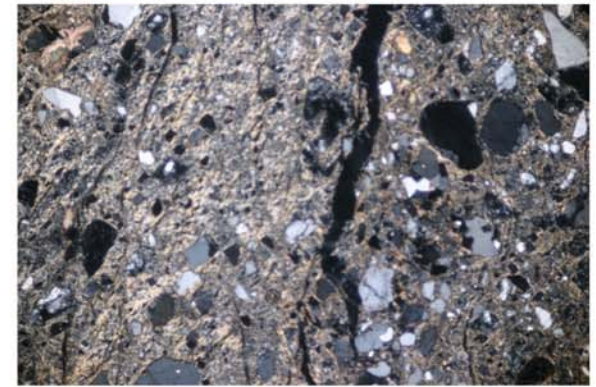
[Displacement sense of shatter zone]
 Observation of thin section of B14-2 depth 109.16m (vertical components)

• Fault gouge 1
 Consists of the brown matrix of fine grain, as well as quartz, feldspar, granite porphyry and cataclasite fragments and that are semi-circular or sub-angular gravels with diameters of 0.02 mm to 5mm. The matrix contains lots of clay minerals and calcite. The displacement sense of normal fault can be recognized from R1 and P.

• Fault gouge 2
 Consists of the brown matrix of fine grain, as well as quartz, feldspar, cataclasite fragments and that are semi-circular or sub-angular gravels with diameters of 0.02 mm to 1mm. The matrix contains lots of clay minerals. The displacement sense of normal fault can be recognized from P.

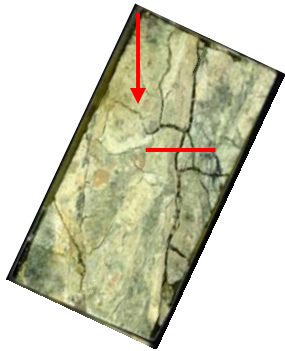
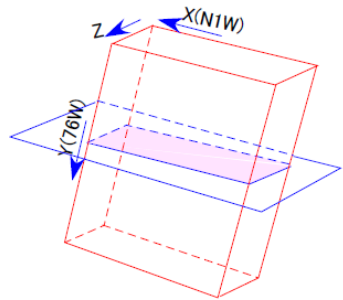
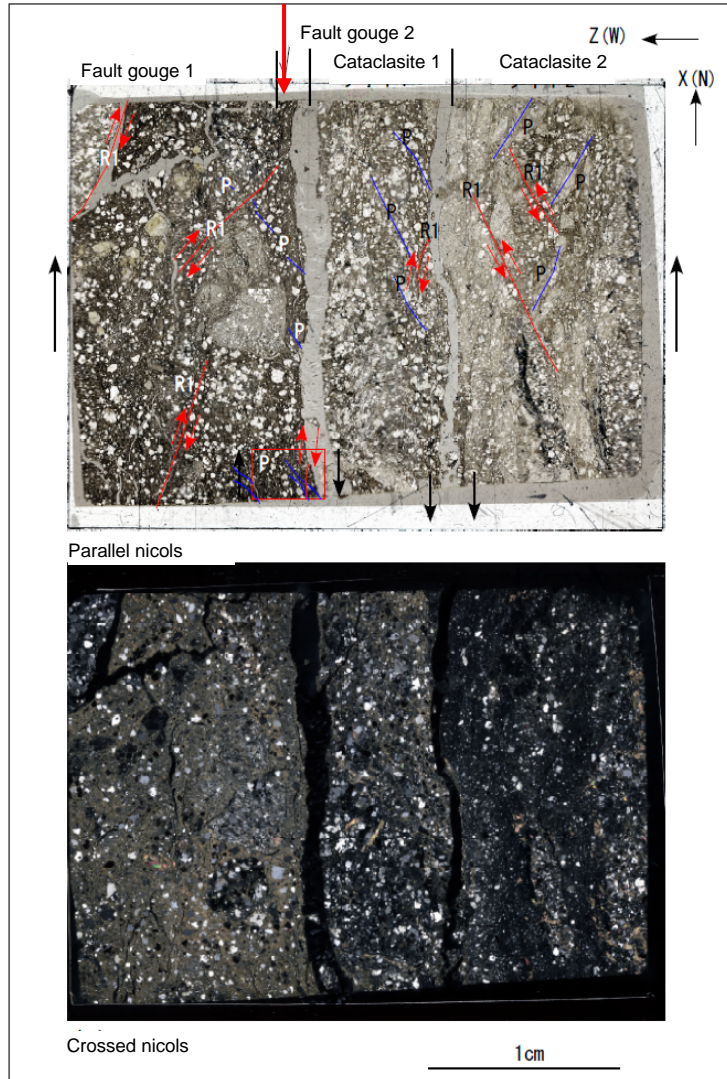
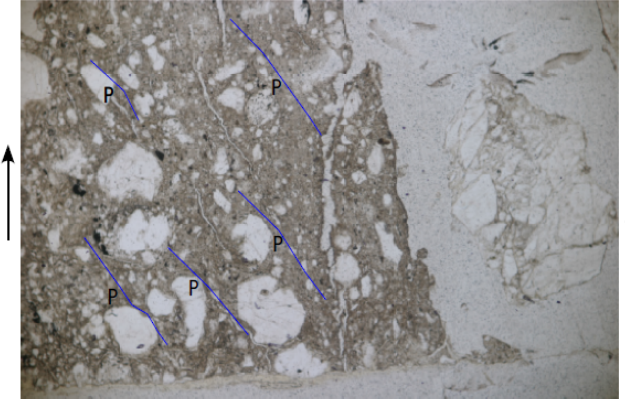
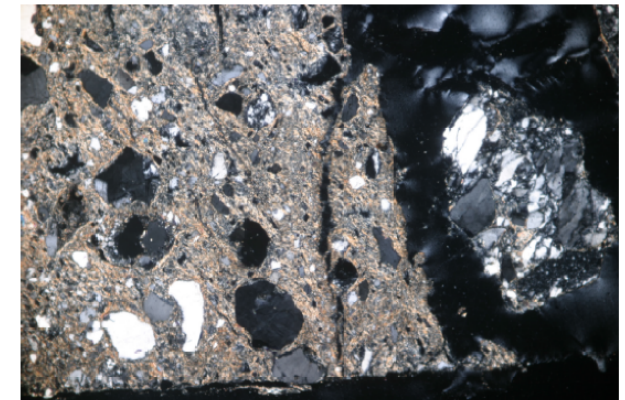
[Displacement sense of shatter zone]
 Observation of thin section of B14-2 depth 109.16m (horizontal components)

- Fault gouge 1
 Consists of the brown matrix of fine grain, as well as quartz, feldspar, apfite and cataclasite fragments and that are semi-circular or sub-angular gravels with diameters of 0.02 mm to 7mm. The matrix contains lots of clay minerals and calcite. The displacement sense of right-lateral slip can be recognized from R1 and P.

- Fault Gauge 2 (last slip)
 Consists of the brown matrix of fine grain, as well as quartz, feldspar, cataclasite fragments and that are semi-circular or sub-angular gravels with diameters of 0.02 mm to 1mm. The matrix contains lots of clay minerals. The displacement sense of right-lateral slip can be recognized from R1 and P.

- Cataclasite 1
 Consists of the brown-gray matrix of fine grain, as well as quartz, feldspar, apfite and cataclasite and that are sub-angular or semi-circular gravels with diameters of 0.1 mm to 8mm. The matrix contains lots of clay minerals and calcite. The displacement sense of right-lateral slip can be recognized from R1 and P.
