Newly obtained data after February 5, 2013

D-1 trench (geological profile)

Geologic stratigraphic sequence of D-1 trench

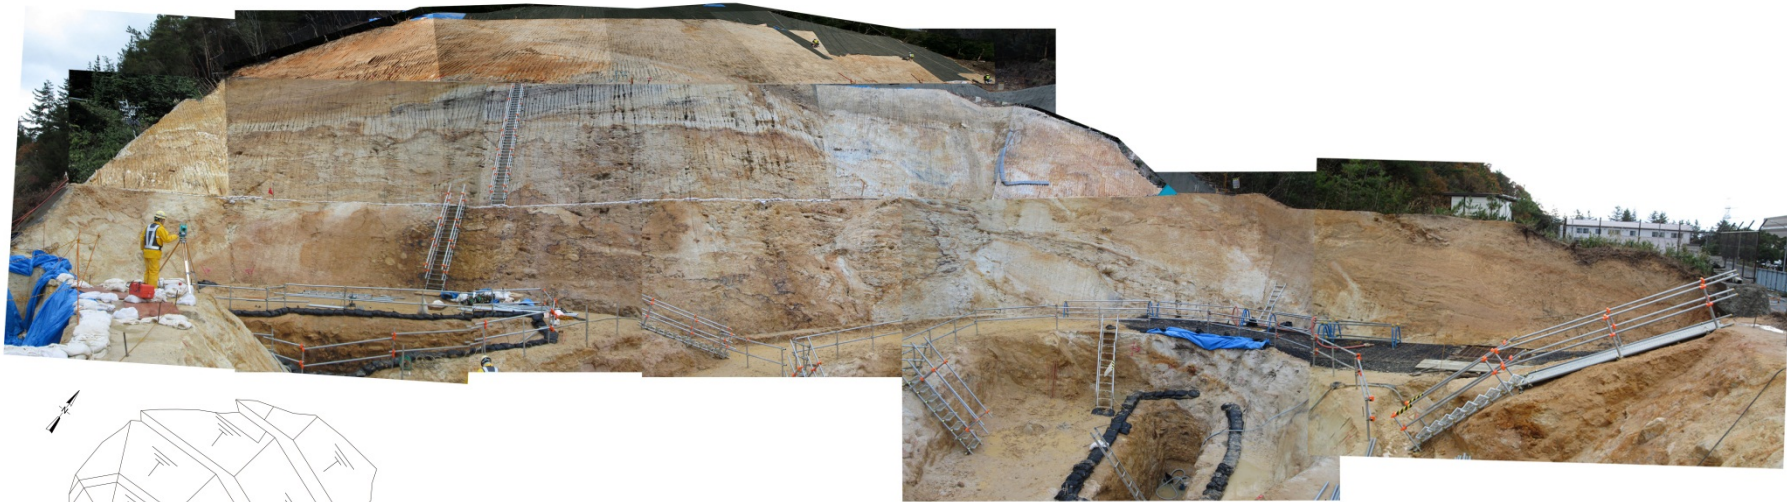
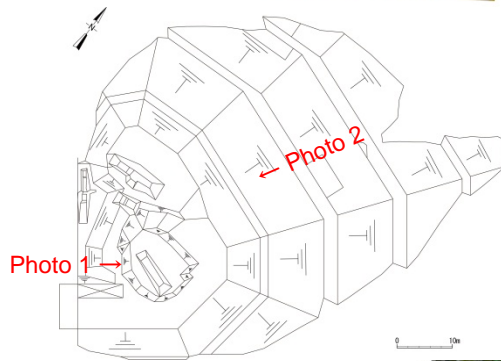
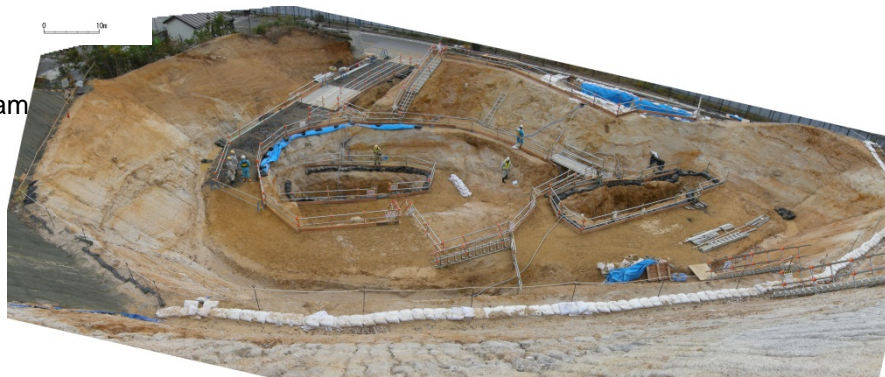
Photo of D-1 trench

- K Fault has displaced lower part of layer ③ but has not displaced upper part of layer ③ and layer ⑤ that is located above layer ③.

- A tephra consist of hornblende is recognized at lower part of layer ⑤.
- That tephra has a correlation with Mihama-tephra from refractive index and ingredient composition.
- Accordingly, the depositional age of lower part of layer ⑤ can be considered stage 5e.

- K-fault was not been active at least in and after the Late Pleistocene (about 120,000-130,000 years ago).

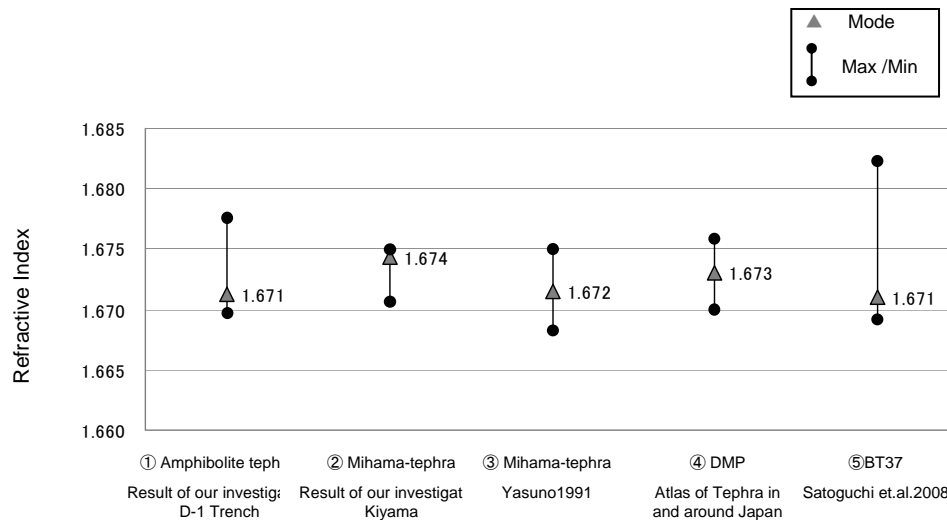
Refractive index and main ingredient analysis

- Refractive index of hornblende tephra that is detected from lower part of layer⑤ beneath K-Tz ash fall layer is 1.670-1.678.
- From the data of refractive index, there is a possibility that the hornblende tephra has a correlation with the following three tephtras:
 - Mihama-tephra (located in lower part of median terrace marine deposit beneath SK (Sanbe-Kisuki, 110-115ka [Atlas of Tephra in and around Japan])[Yasuno1991])
 - DMP (Daisen-Matsue, <130ka [Atlas of Tephra in and around Japan])
 - BT37 (Lake Biwa-Takasima oki boring, 127.6ka [Nagahasi, et al.])
- The main ingredient component of the hornblende tephra is almost same as that of Mihama-tephra, which occurs around power station.
- Because a hornblende tephra of lower part of layer⑤ has a correlation with Mihama-tephra, the depositional age of lower part of layer⑤ can be considered stage5e.

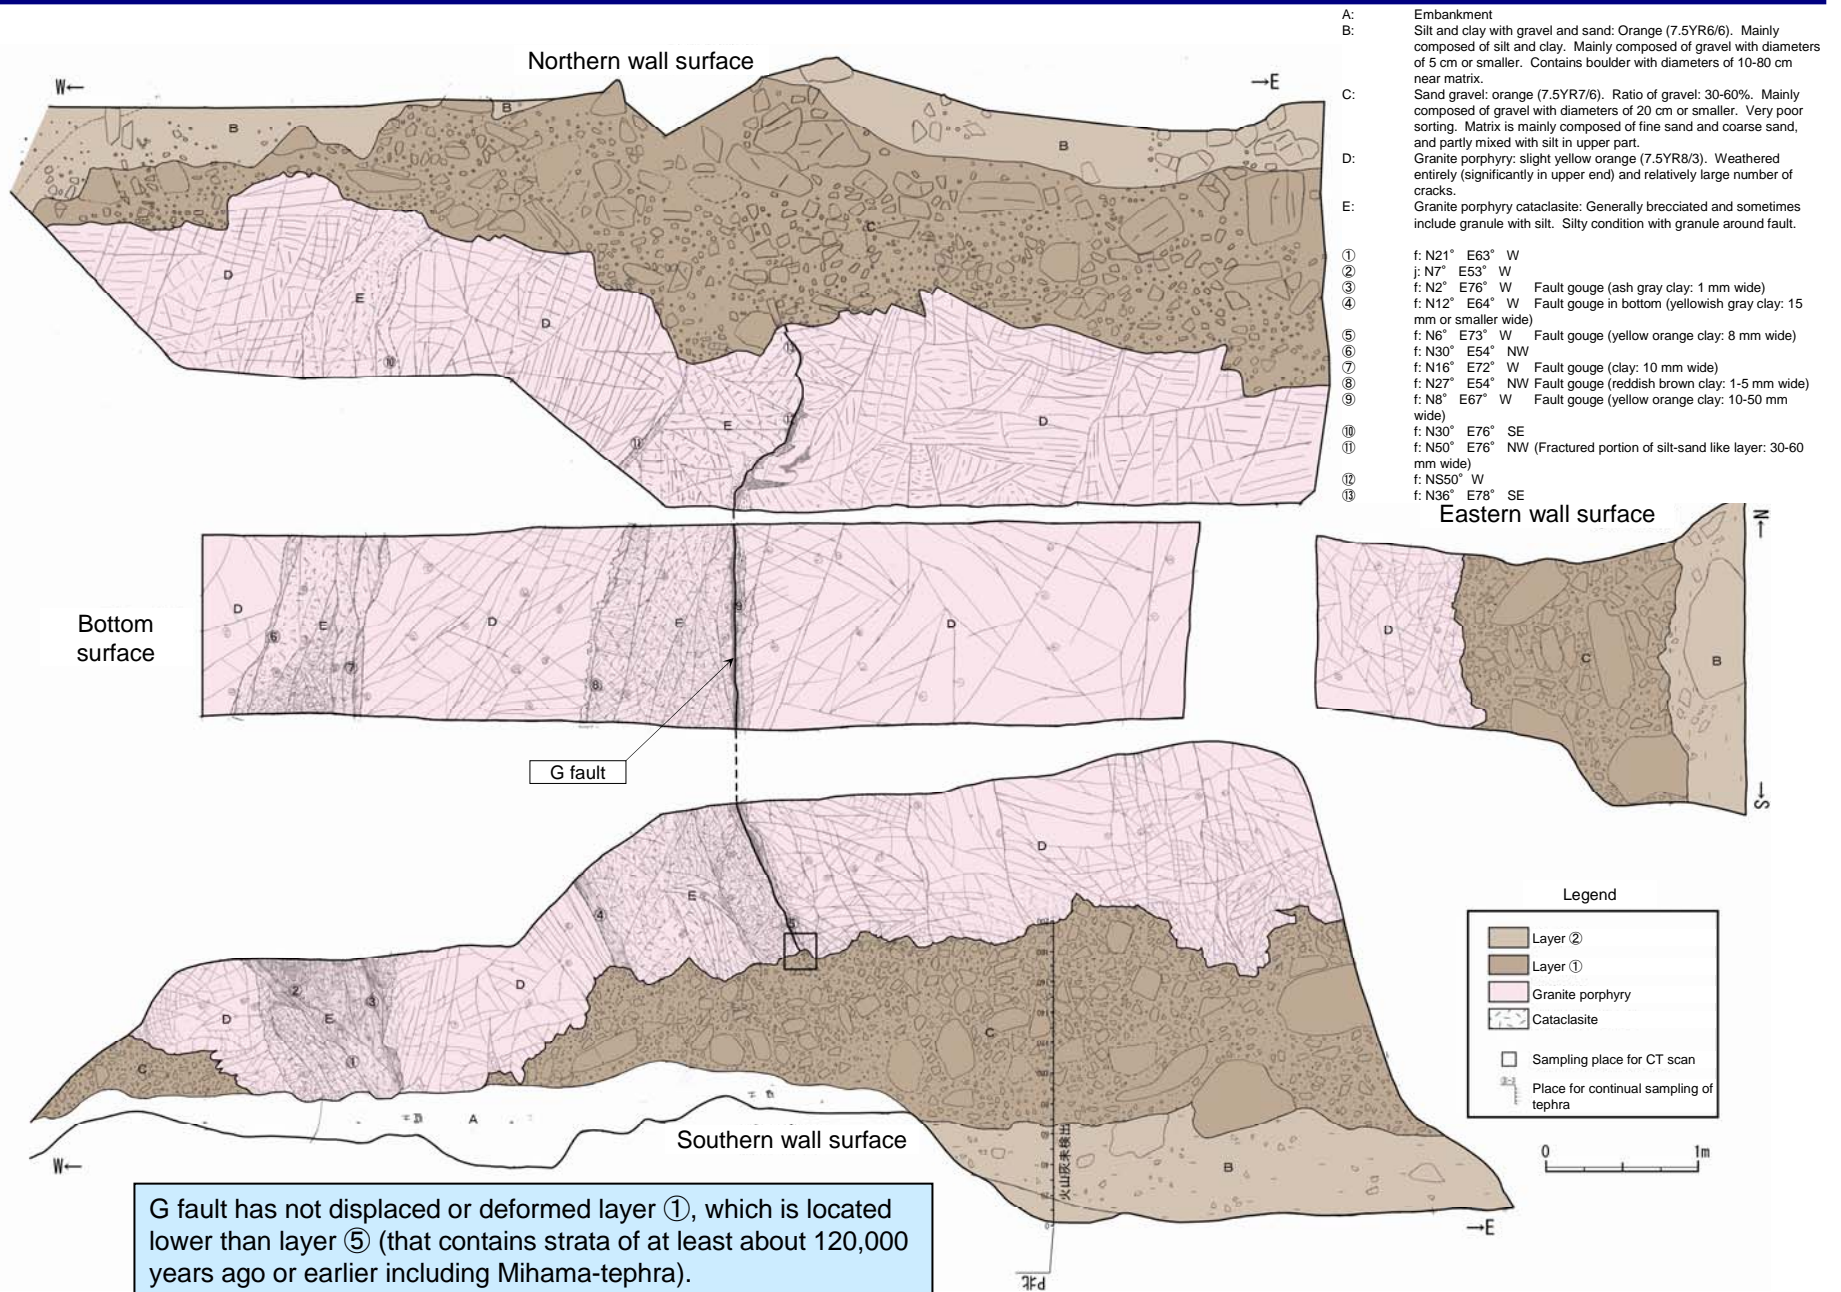
D-1 trench (sketch of northern pit)

G fault has not displaced or deformed layer ①, which is located lower than layer ⑤ (that contains strata of at least about 120,000 years ago or earlier including Mihama-tephra).

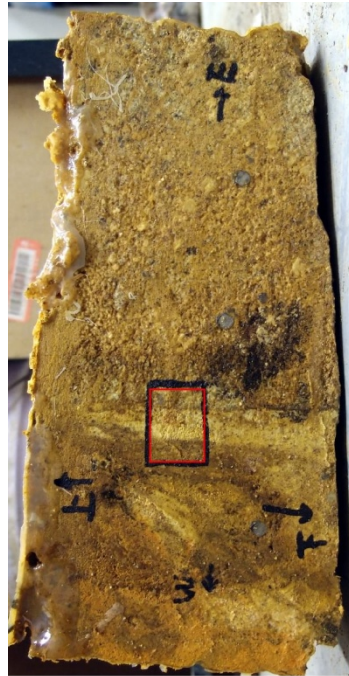
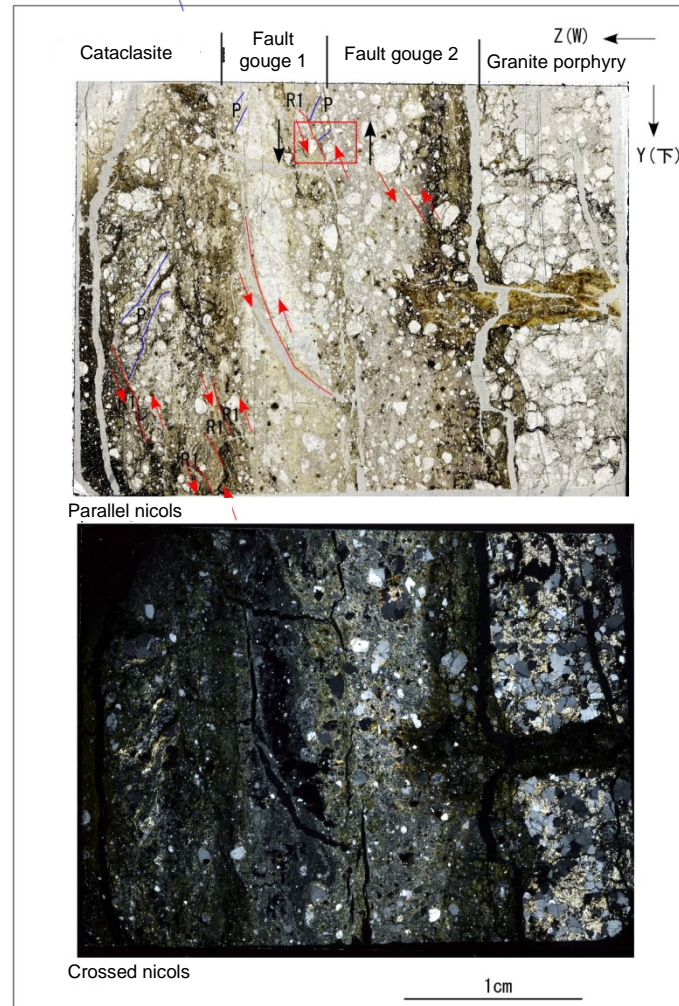
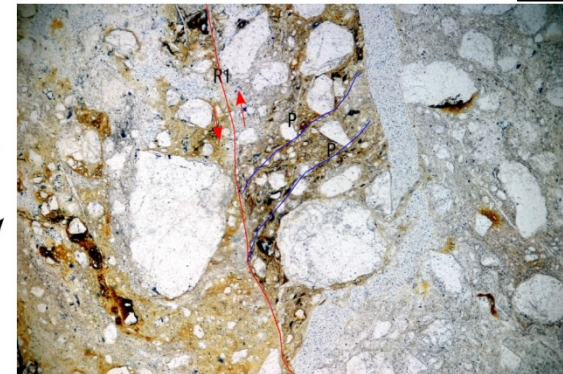
[Displacement sense of shatter zone] Observation results of thin section from G fault in the south of northern pit of D-1 trench (vertical components)

Area within red frame is enlarged

Consists of the brown-gray matrix of fine grain, as well as quartz, feldspar and cataclasite fragments that are sub-angular or semi-circular gravels with diameters of 0.1 to 3 mm. The matrix contains less clay minerals. The displacement sense of normal fault can be recognized from R1 and P.

Consists of the brown-gray matrix of fine grain, as well as quartz, feldspar and cataclasite fragments that are semi-circular or sub-angular gravels with diameters of 0.1 to 10 mm. The matrix contains lots of clay minerals.

The displacement sense of normal fault can be recognized from R1 and P.

Consists of the brown-gray matrix of fine grain, as well as quartz, feldspar and cataclasite fragments that are semi-circular or sub-angular gravels with diameters of 0.1 to 2 mm. Ratio of fragments is lower than in fault gouge 1. The matrix contains lots of clay minerals. The displacement sense of unclear normal fault can be recognized from R1.

Consists of granite porphyry, quartz and feldspar fragments with diameters of 0.1 to 2 mm.

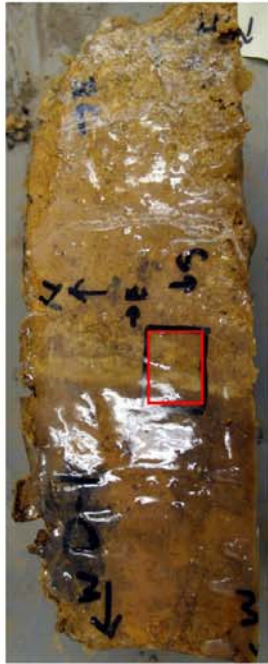
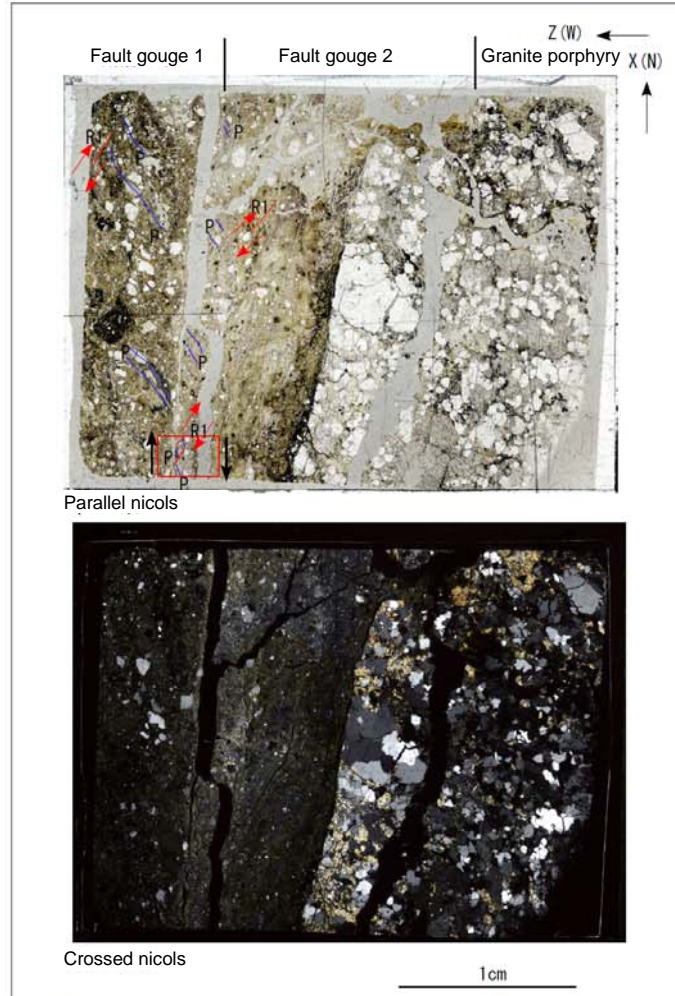
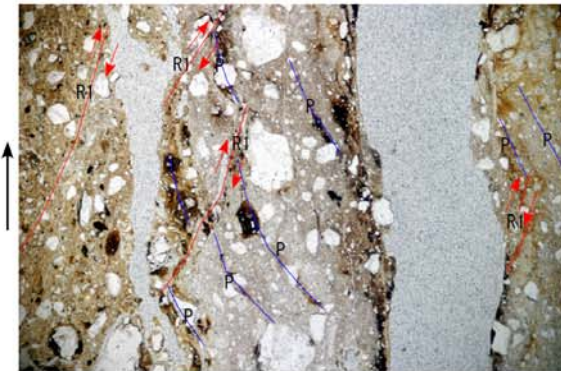
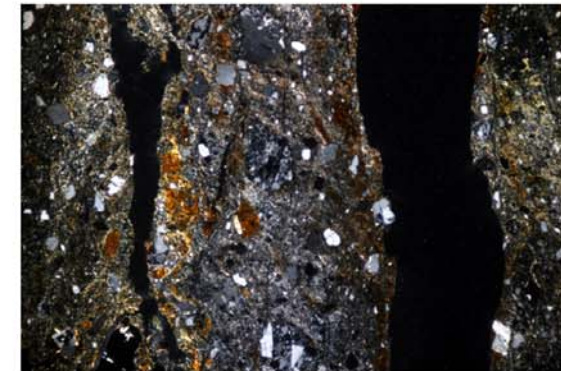
[Displacement sense of shatter zone] Observation results of thin section from G fault in the south of northern pit of D-1 trench (horizontal components)

Area within red frame is enlarged

Parallel nicols

Crossed nicols

- Fault gouge 1
Consists of the brown-gray matrix of fine grain, as well as quartz, feldspar and cataclaste fragments that are sub-angular or semi-circular gravels with diameters of 0.1 to 3 mm. The matrix contains lots of clay minerals. The displacement sense of right-lateral slip can be recognized from R1 and P.
- Fault gouge 2 (last slip)
Consists of the brown-gray matrix of fine grain, as well as quartz, feldspar and cataclaste fragments that are semi-circular or sub-angular gravels with diameters of 0.1 to 2 mm. Ratio of fragments is lower than in fault gouge 1. The matrix contains lots of clay minerals. The displacement sense of right-lateral slip can be recognized from R1 and P.
- Granite porphyry
Consists of granite porphyry, quartz and feldspar fragments with diameters of 0.1 to 2 mm.

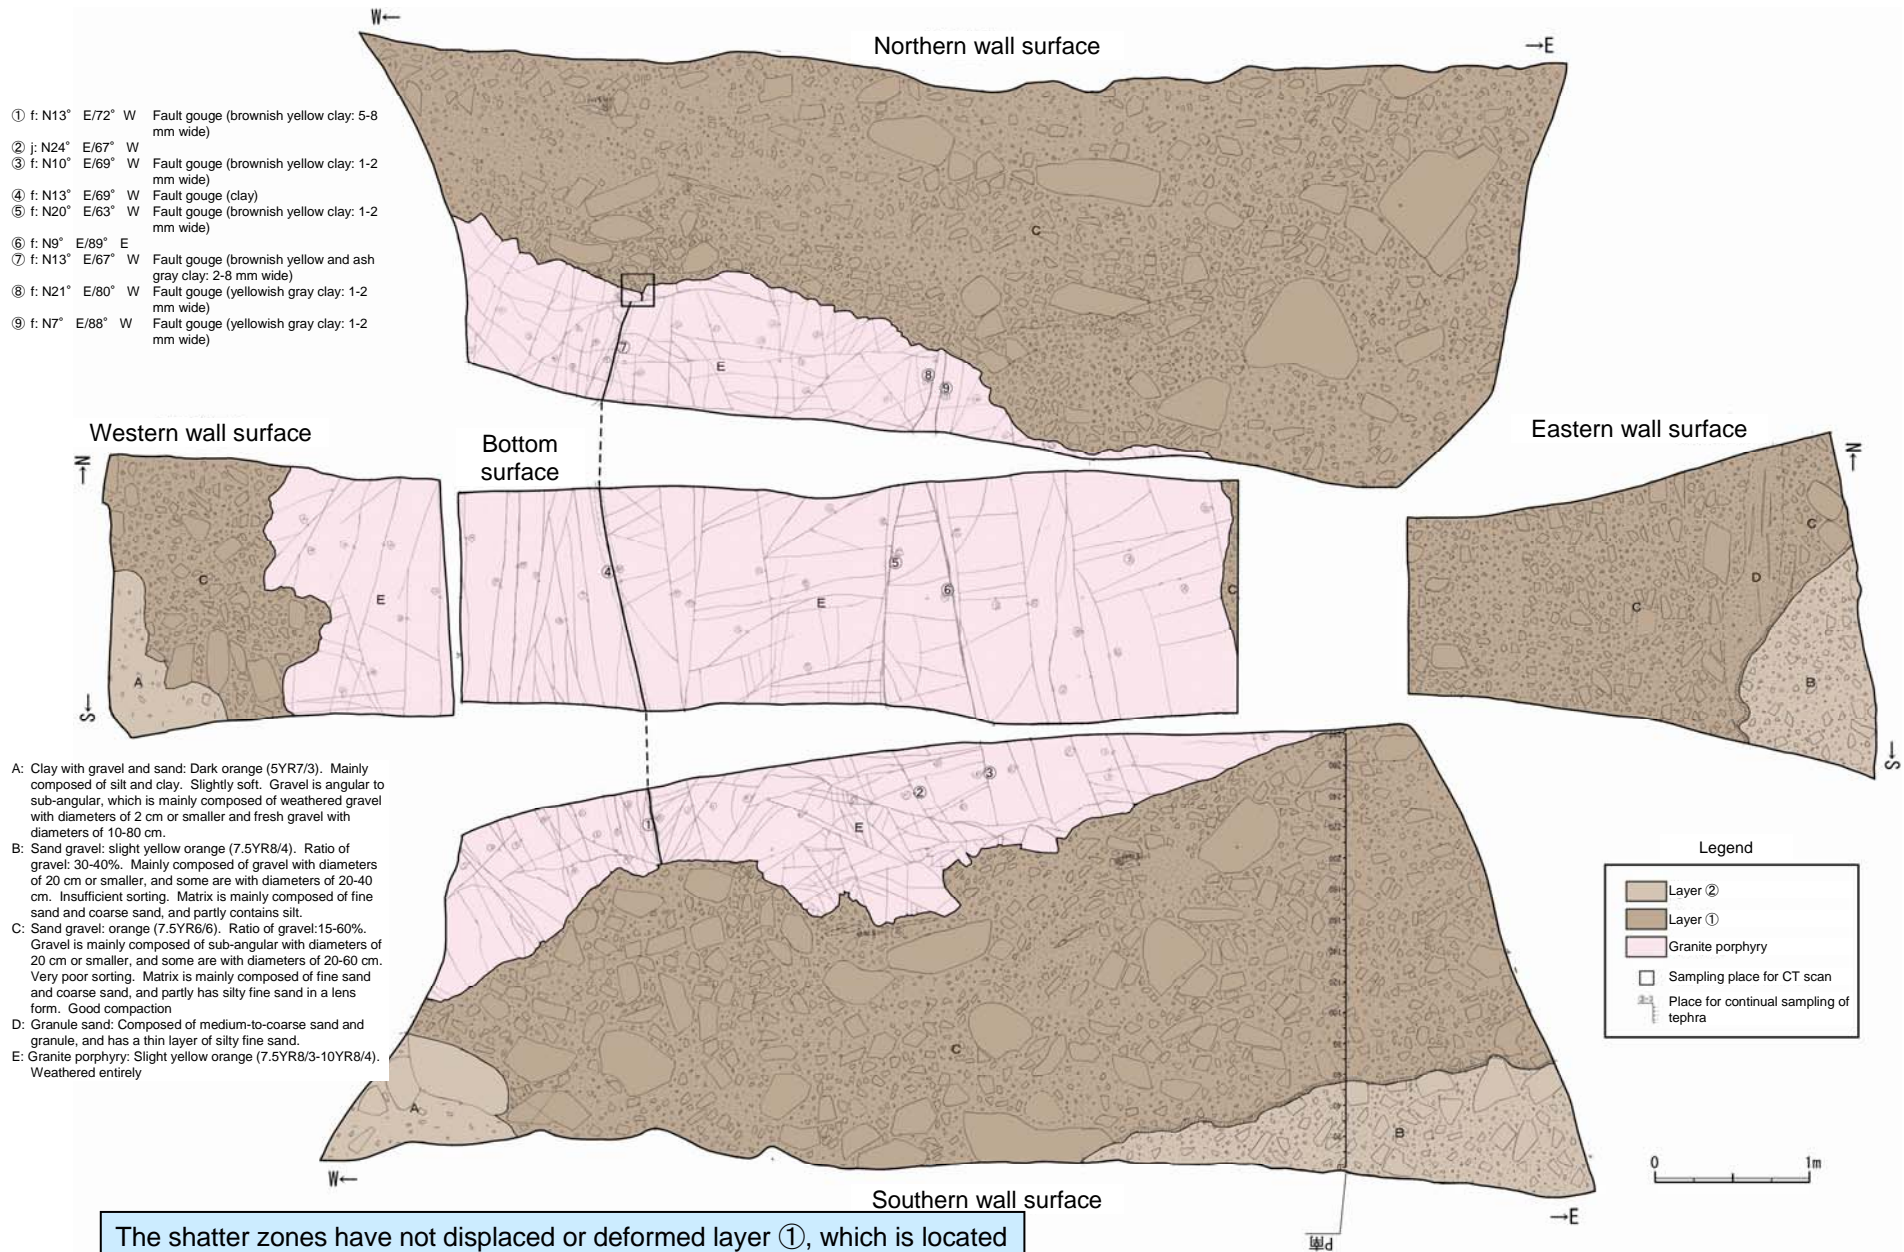
D-1 trench (sketch of southern pit)

The shatter zones have not displaced or deformed layer ①, which is located lower than layer ⑤ (that contains strata of at least 120,000 years ago or earlier including Mihama-tephra).

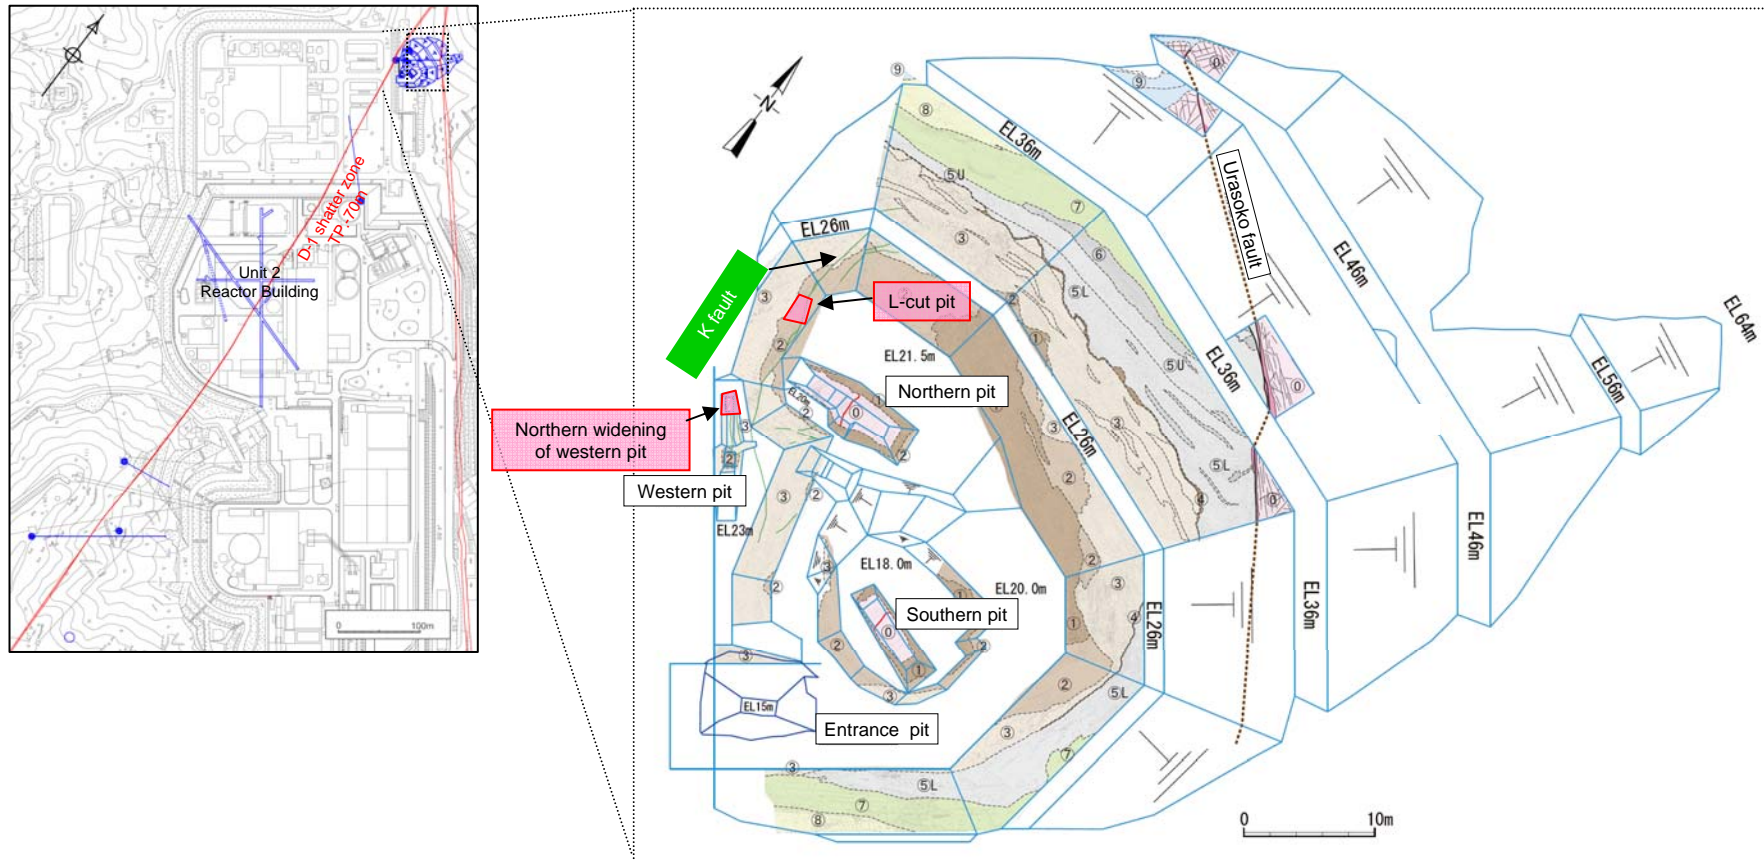
Evaluation on continuity of K fault

- At the K fault, a reverse fault, which is located between basement rock and deposit, can be recognized from observation of L-cut pit and northern widening of western pit.
- It can be recognized that fault strike is a direction of N-S in L-cut pit but it changes to a direction NNW-SSE in northern widening of western pit. It is suggested that the K fault does not extend to the direction of Unit 2 reactor building.
- Additional drilling and pit investigation are undergoing now. To study continuity and cause of K fault, additional data is being obtained.

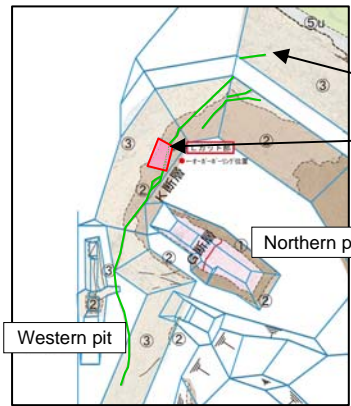
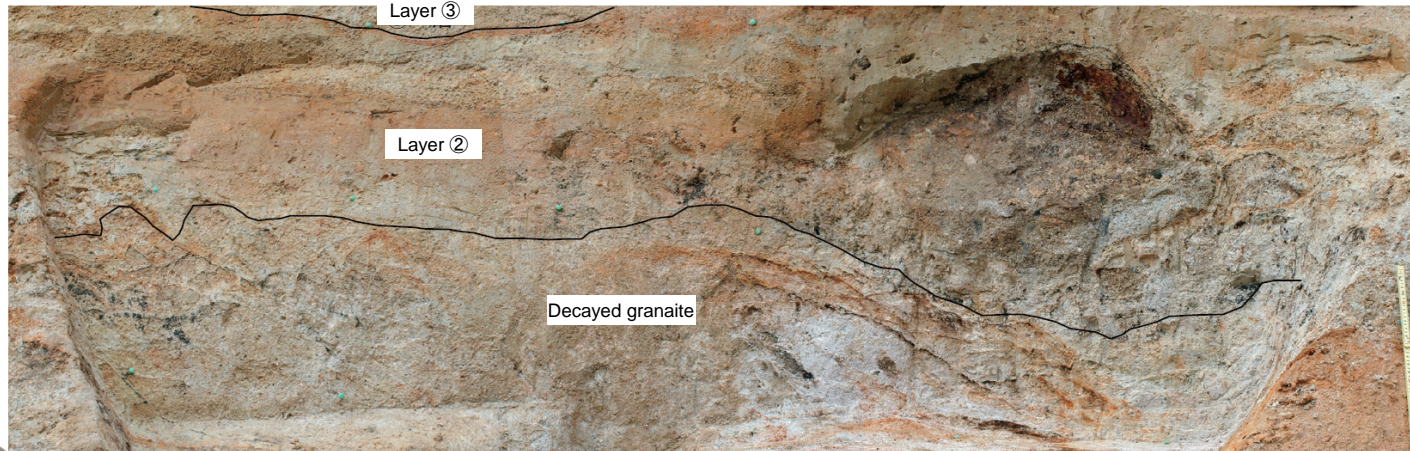
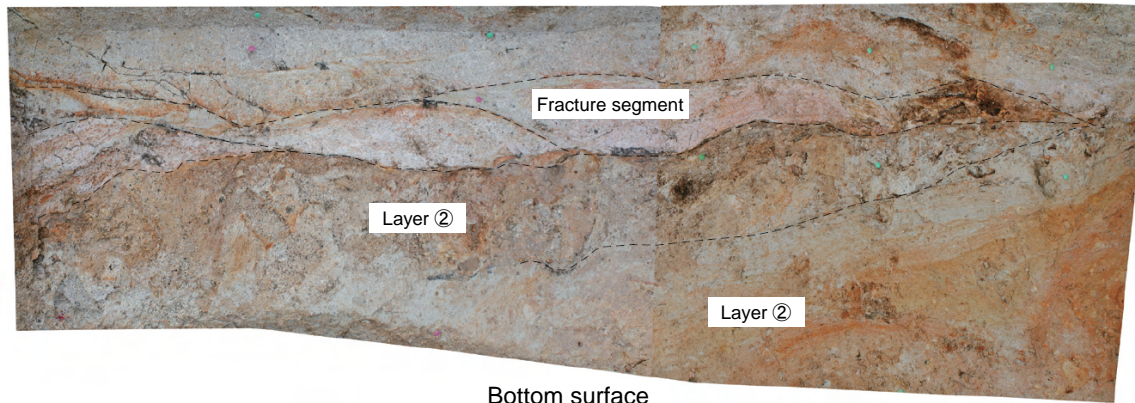
Photographs of L-cut pit

K fault

Fracture segment

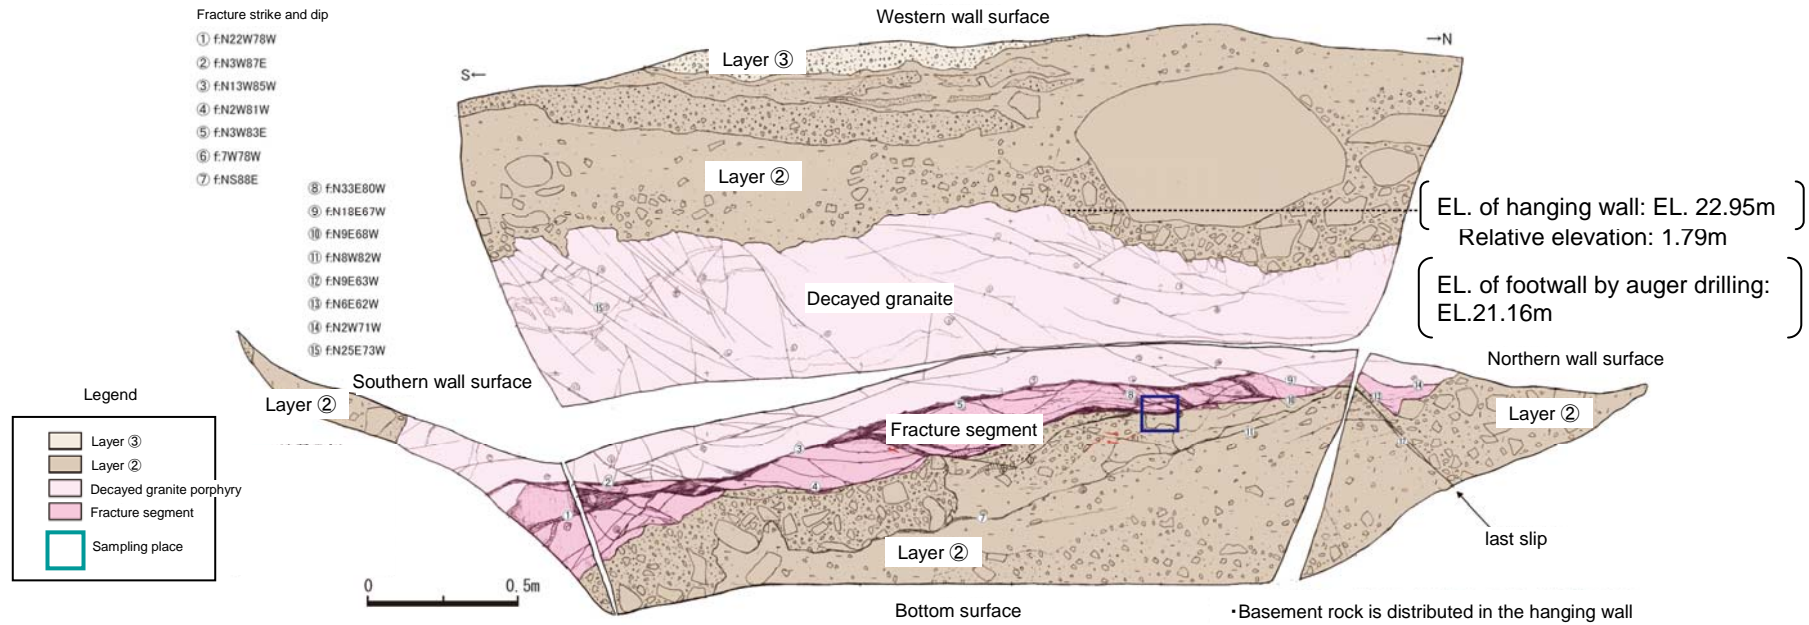
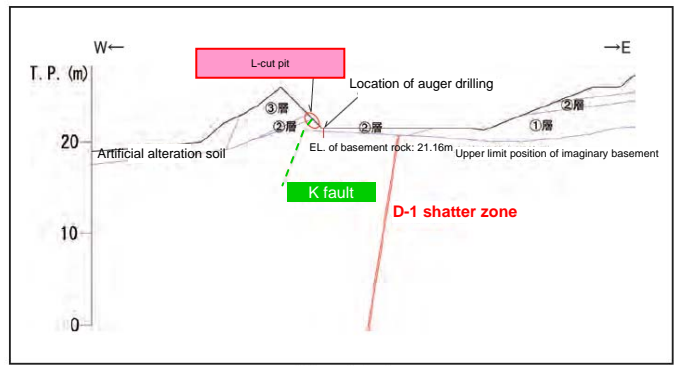
Sketch of L-cut pit

• Basement rock is distributed in the hanging wall of the shear plane, deposit is distributed in the footwall.

• In the hanging wall above a shear plane, 10-30cm width fracture segment is distributed. In the deposit (Layer ②), fracture and shear structure is developing along the line of a boundary plane with the basement. A linear fault gouge is not recognized. The R1 planes with a few centimeters displacement finely slips the shear planes.

• At the R1 plane in the fracture segment and the deposit (Layer ②), right-lateral slips are observed.

• The relative vertical is 1.79m, that is calculated from the upper limit surface of the hanging wall and auger boring close to the footwall.

- K fault was recognized between decayed granite porphyry and layer ② at L-cut pit.
- Strike and dip of K fault is a direction of N-S and high-angle westerly dip. K fault consist of gray fracture segments with hydrothermal alteration.
- K fault is a reverse fault with right-lateral slip. Relative vertical displacement of basement rock is about 1.8m.

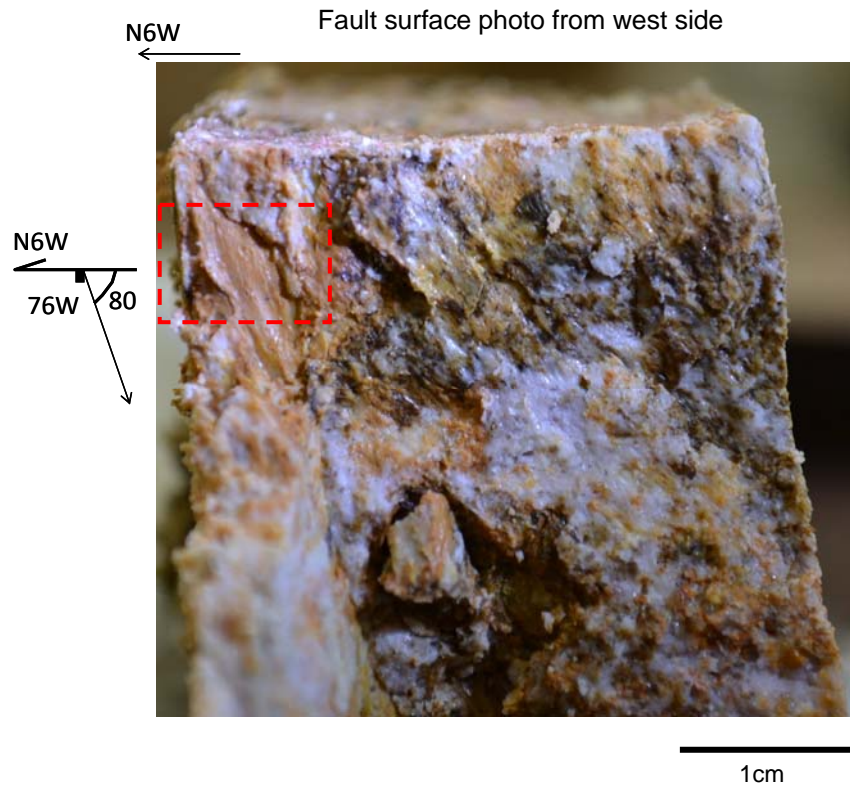
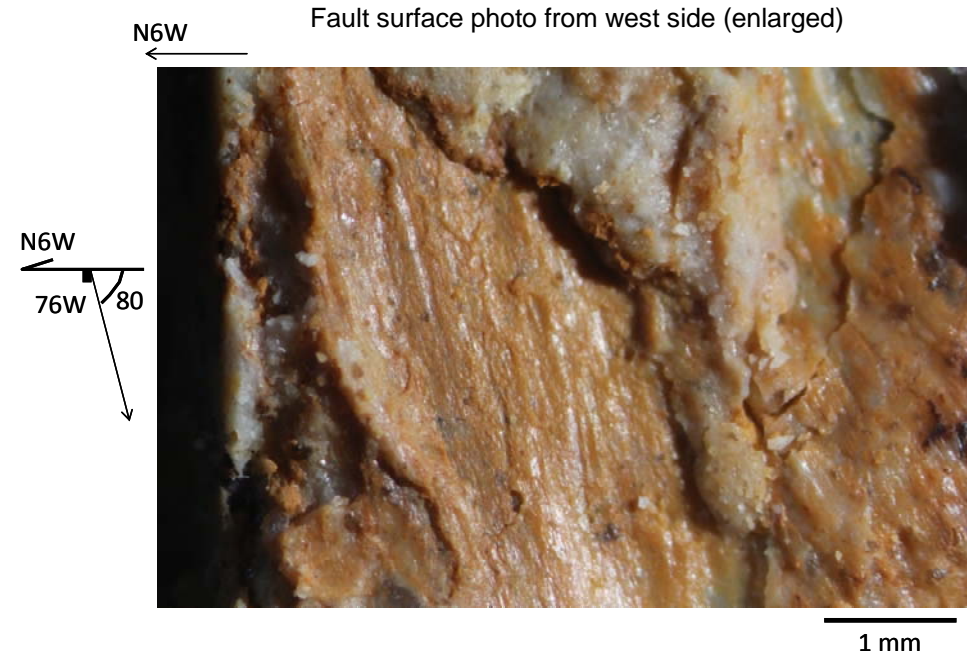
The slickenline of K fault in the L-cut pit (photo)

- At the L-cut pit, a block of K-fault (N-S strike) was sampled and slickenline of the last slip was observed.
- In the result, it is confirmed that the reverse fault displacement component is dominant.

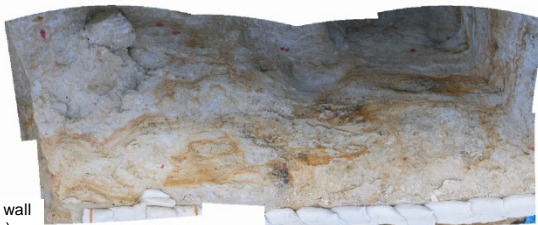
Eastern wall (north)

D-1 trench (sketch of western pit)

- The shatter zones running to the directions of N-S and NNW-SSW are recognized in the basement rock at the northern widening of western pit.
- The K fault, which displaces and deforms layer ③, has N-S direction strike in the basement rock at the northern widening of western pit. The strike changes its direction to NNW-SSW in the western pit.
- The fracture segment with N-S direction strike does not displace and deform layer ③ in the south part from the bend.

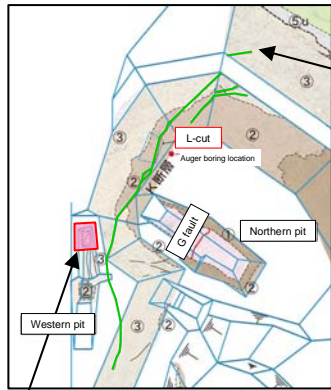
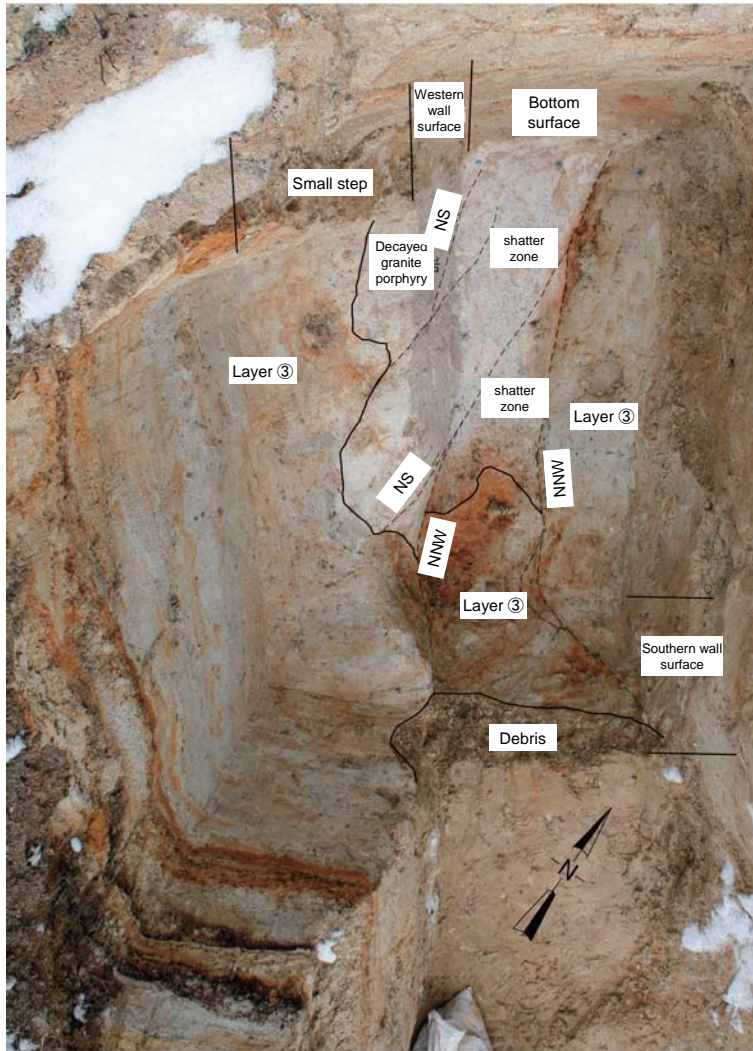
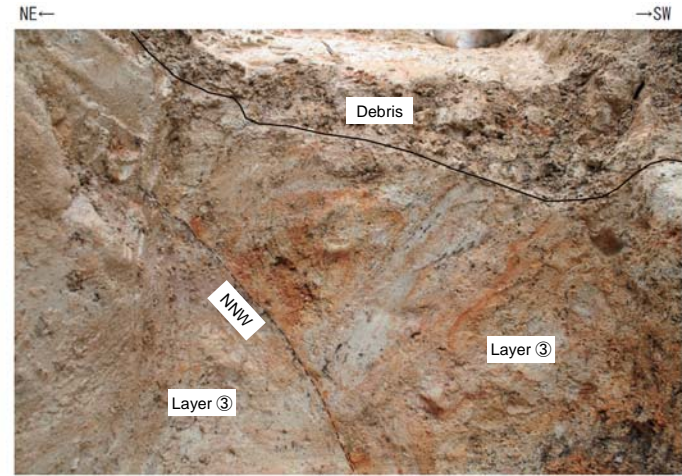
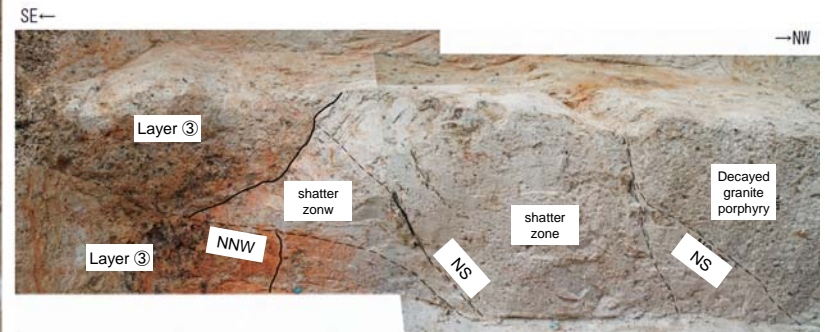
Northern widening of western pit (photo)

K fault

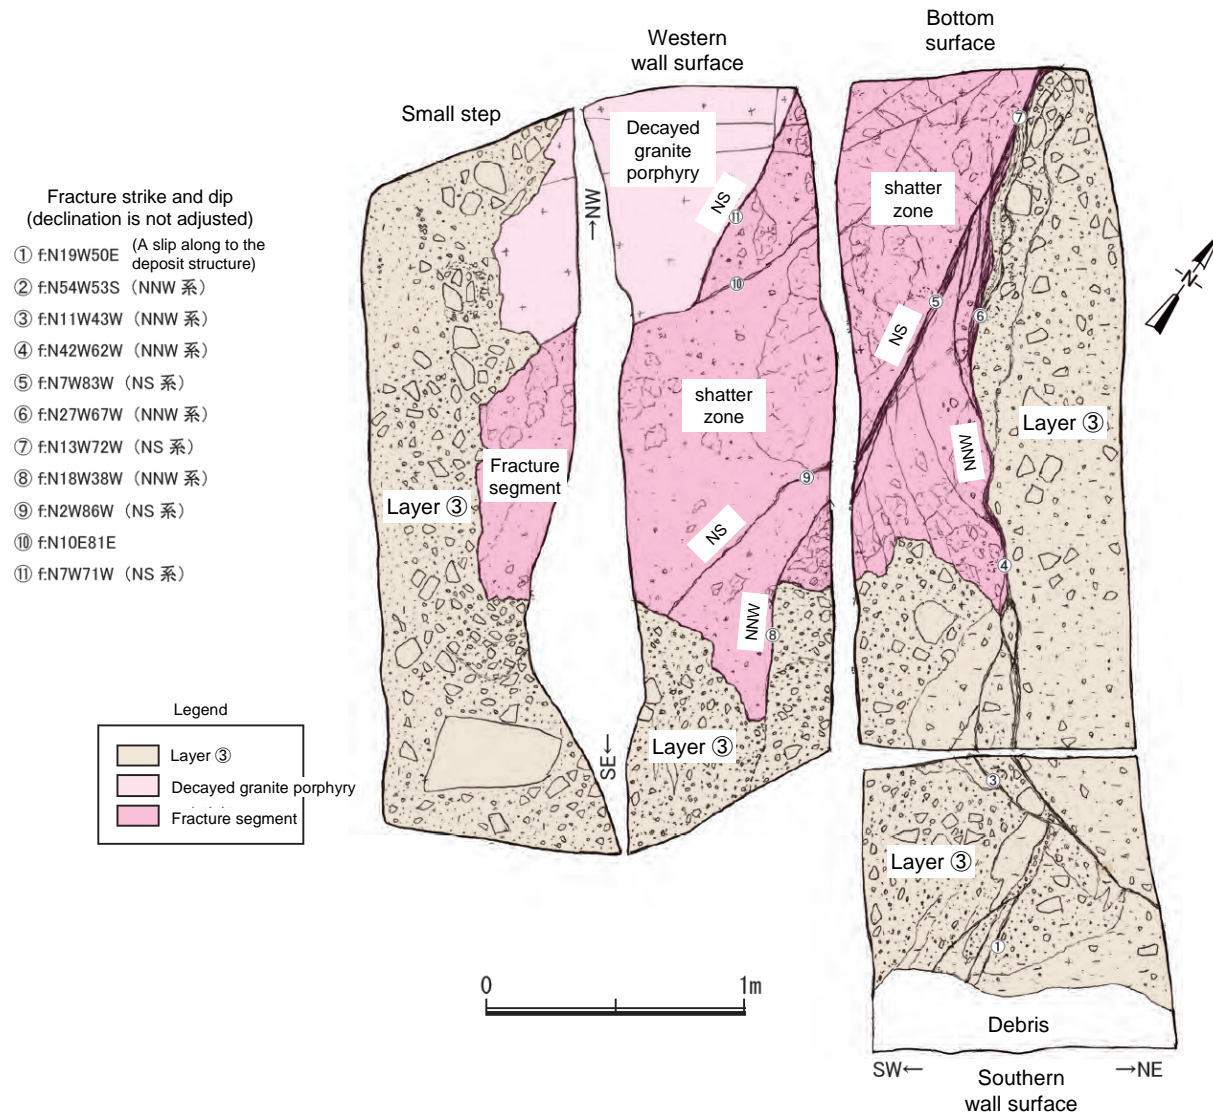
Northern widening of western pit (sketch)

- The shatter zones running to the directions of N-S and NNW-SSW are recognized in the basement rock at the northern widening of western pit.
- The K fault, which displaces and deforms layer ③, has N-S direction strike in the basement rock at the northern widening of western pit. The strike changes its direction to NNW-SSW in the western pit.
- The fracture segment with N-S direction strike does not displace and deform layer ③ in the south part from the bend.
